1 Sampling and characterization of the Warsaw Railway Station

The following paragraphs summarize the main findings and information regarding the sampling and characterization of the Śródmieście WKD Station Pavilion, one of the case studies chosen as part of INNOVACONCRETE project.

1.1 Information on the monument

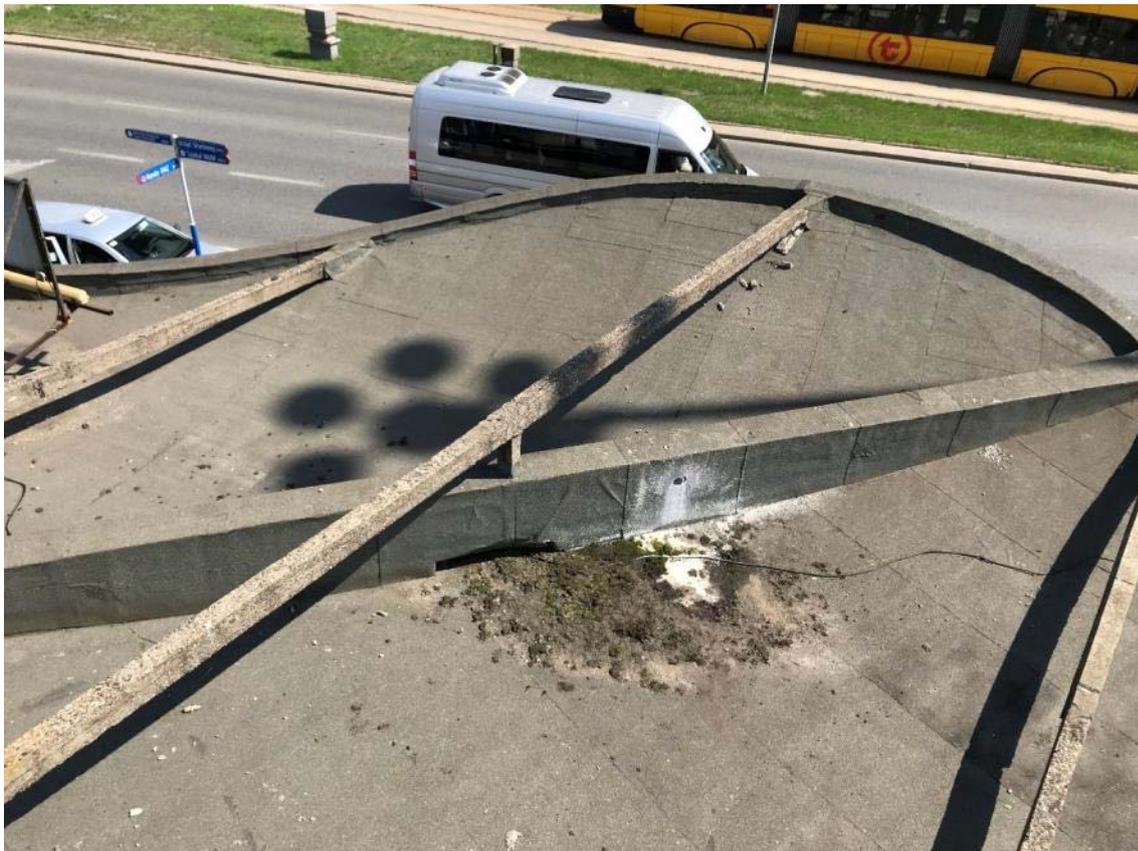
These secondary beams have got a 0.12 x 0.17 m² section. From the undertaken scanning, it could be concluded that the bracing beam has got a middle bar and two very fine meshes in the top and bottom sections. The concrete covering of these elements is in all measurements under the limit established by Eurocode, being particularly sensitive to carbonation problems due to not having any protection as the other elements.

Figure 15: Srodmiescie WKD Station Pavilion bracing beams view, showing no protection. Source: INES Ingenieros 2018.

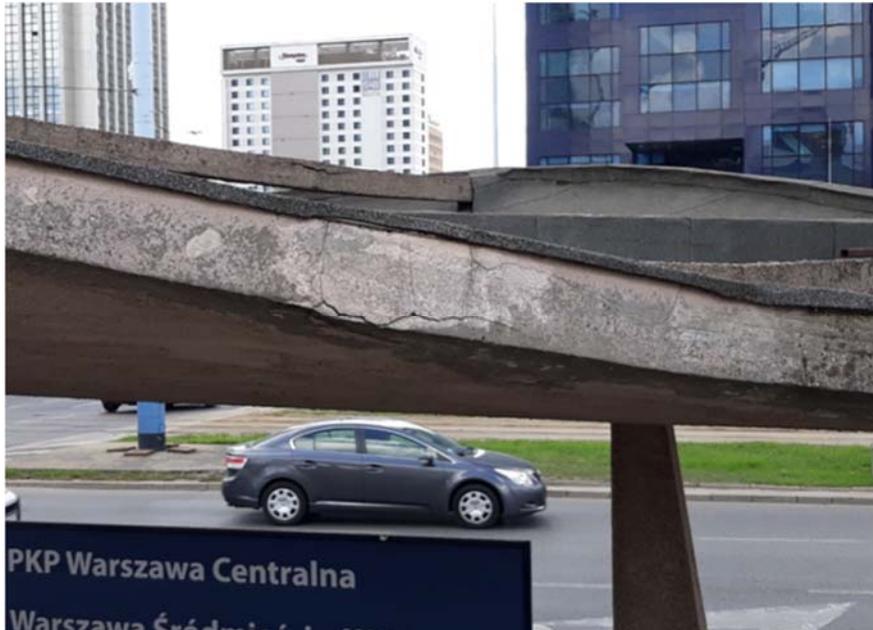
- **Delamination:**

Figure 22: Delamination in Srod miescie WKD Station Pavilion. Source: INES Ingenieros 2018.

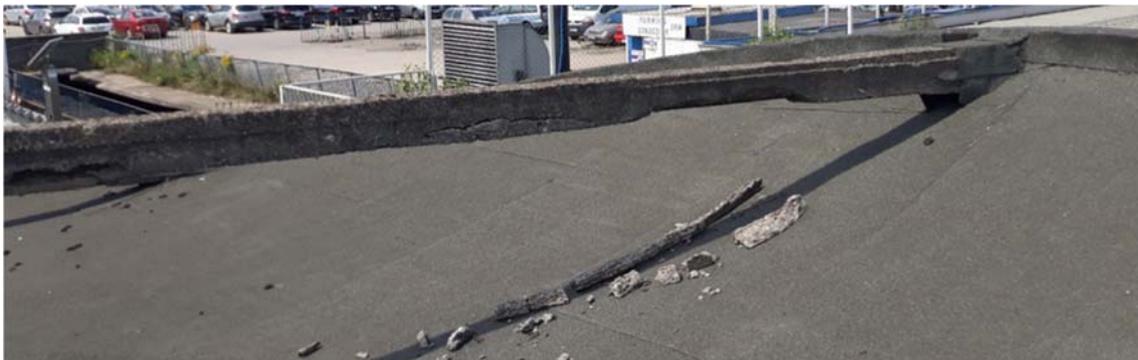
- **Spalling concrete not showing reinforcing rods**

Figure 23: Spalling concrete not showing reinforcing rods in Srod miescie WKD Station Pavilion. Source: INES Ingenieros 2018.

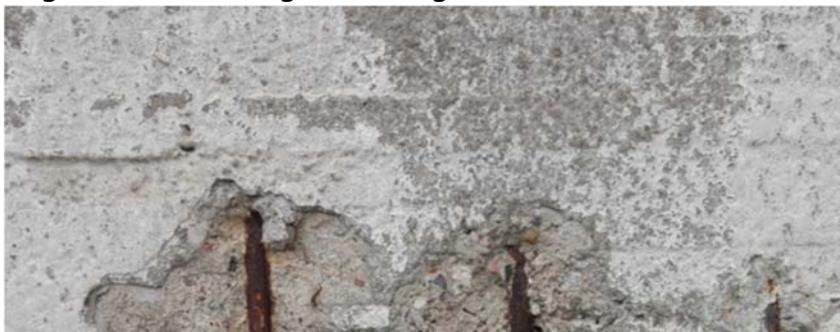
- **Spalling concrete showing reinforcing rods**

Figure 24: Spalling concrete showing reinforcing rods in Srod miescie WKD Station Pavilion. Source: INES Ingenieros 2018.

Corrosion of steel reinforcement can be seen in the previous figure. Besides being present in the reinforcement, the top centre steel beams are also affected by this problem. Not the steel columns.

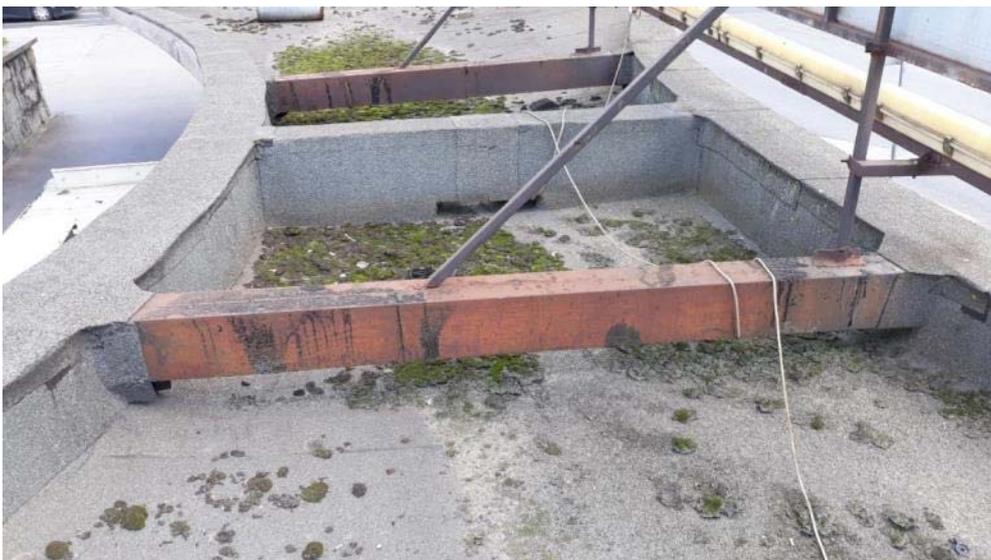
- **Corrosion**

Figure 25: Corrosion in Srod miescie WKD Station Pavilion centre beams. Source: INES Ingenieros 2018.

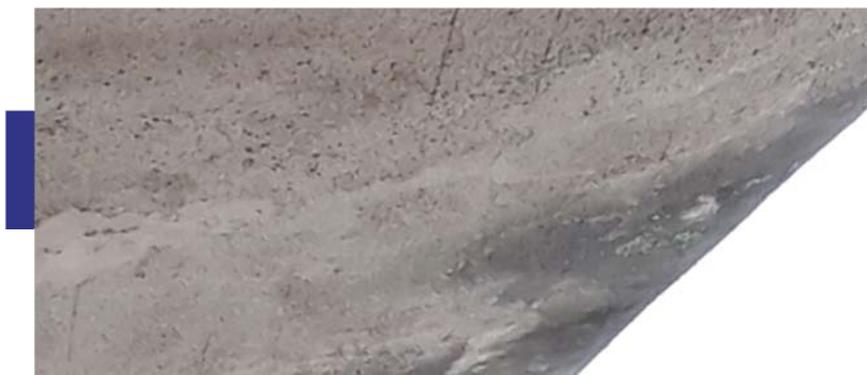
- **Moister**

Figure 26: Moistures in Srodmiessie WKD Station Pavilion deck bottom surface. Source: INES Ingenieros 2018.

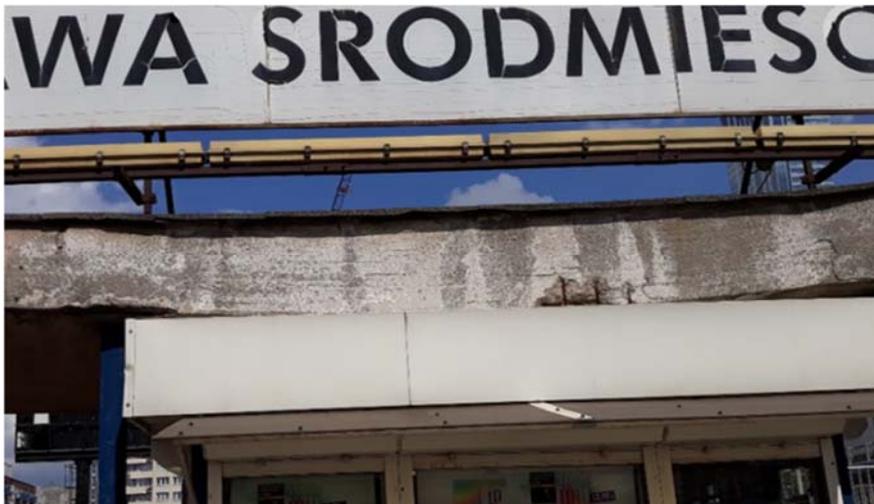
- **Calcareous crusts**

Figure 27: Calcareous crusts in Srodmiessie WKD Station Pavilion edge beam. Source: INES Ingenieros 2018.

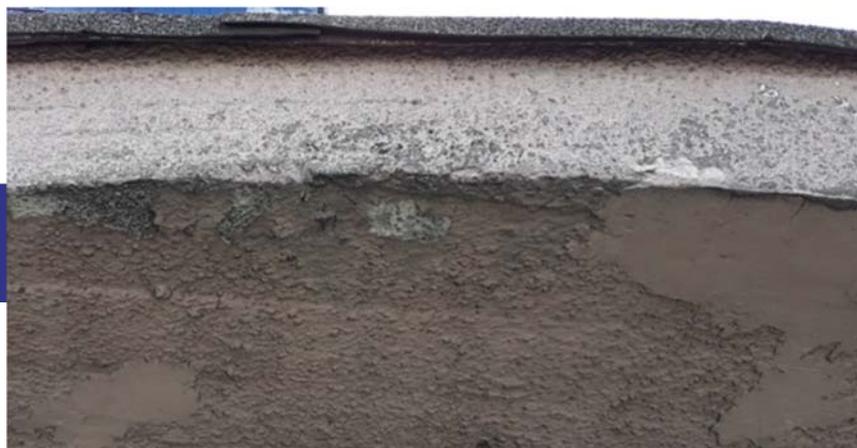
- **Peeling**

Figure 28: Peeling in Srod miescie WKD Station Pavilion deck bottom surface. Source: INES Ingenieros 2018.

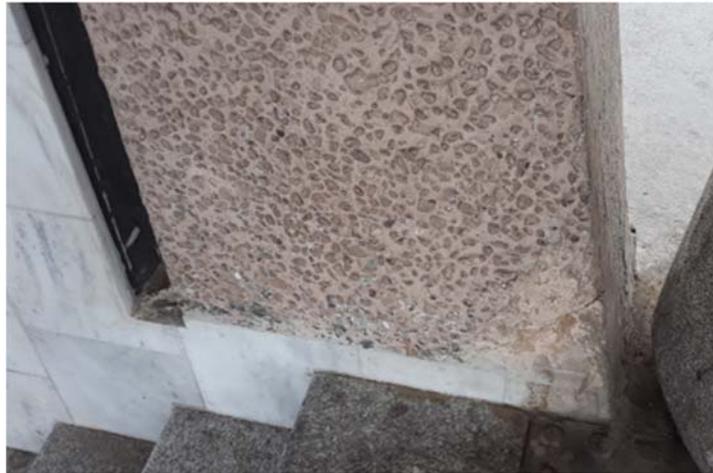
- **Deteriorated joint**

Figure 29: Deteriorated joint in Srod miescie WKD Station Pavilion column bottom. Source: INES Ingenieros 2018.

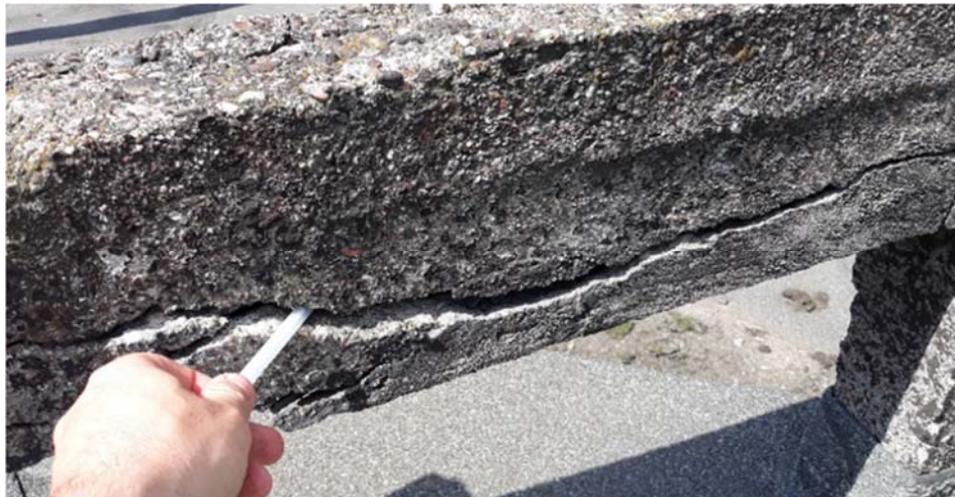
- **Cracks**

Figure 30: Cracks in Srod miescie WKD Station Pavilion bracing beams. Source: INES Ingenieros 2018.

Summarizing, the state of conservation is precarious. While the thin-shell, main beams and columns seem to be in relatively good condition besides some detected damages, the bracing beams have severe mechanical and durable damages that have made them loose a significant section as well as having serious corrosion problems that can lead to structural problems.

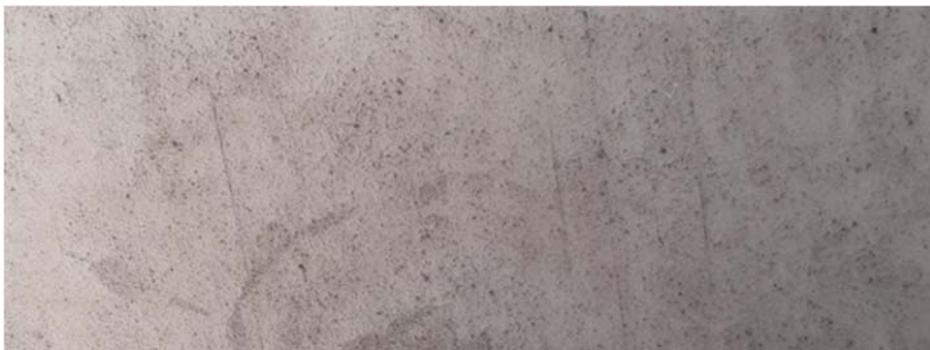
- **Repairs**

Figure 31: Repairs in Srod miescie WKD Station Pavilion deck bottom face. Source: INES Ingenieros 2018.

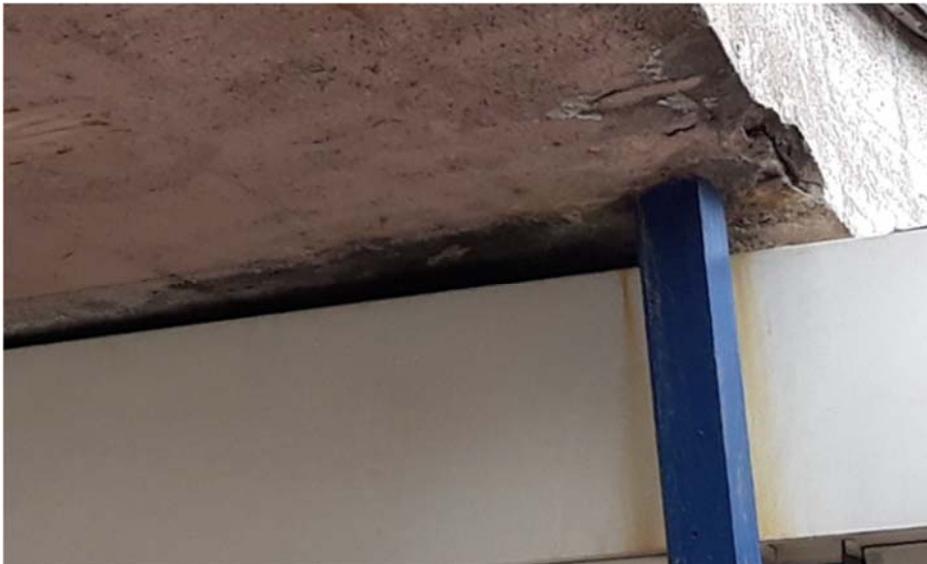
- **Black crust**

Figure 32: Black crust in Srod miescie WKD Station Pavilion deck bottom face. Source: INES Ingenieros 2018.

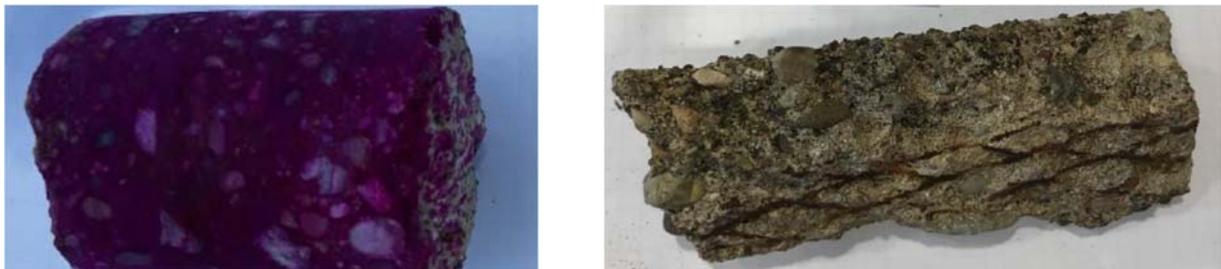
Figure 49: Phenolphthalein applied to different samples, showing no and complete carbonation respectively. Source: INES Ingenieros 2018.
