# 1 Sampling and characterization of the Centennial Hall

## 1.1 Information on the monument

### General Information about the building

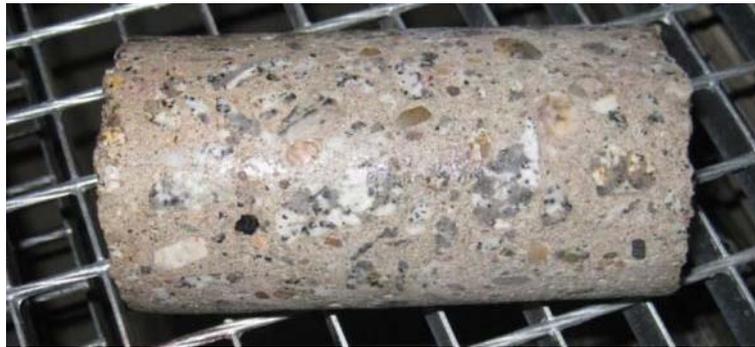
*Core sample extracted from the £ 17 rib (high content of granite aggregate)*

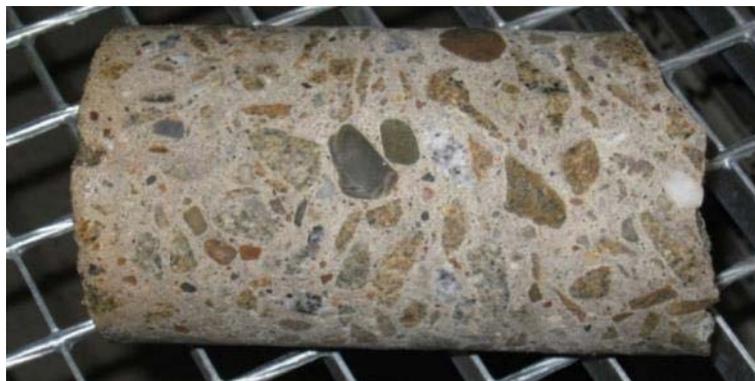
*Core sample extracted from the £ 20 rib (composition dominated by natural aggregate)*

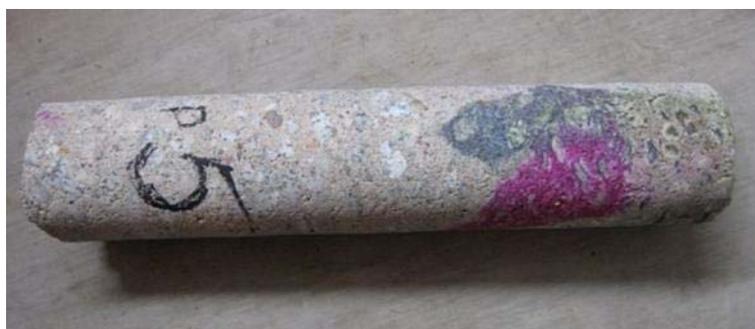
For specimen from 0-1/A to 0-19/B. In the majority of tested locations, the thickness of the carbonated area is no less than 35 mm, although in a number of locations it was found to be much thicker.

*Specimen 0-5 after phenolphthalein and Rainbow Test method*

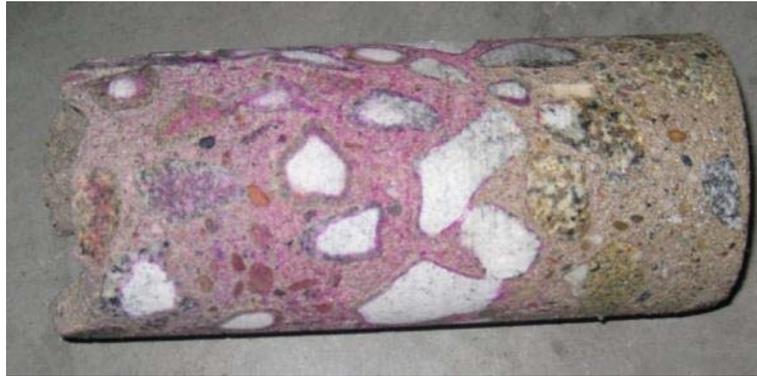
For specimen from O-A1 to O-D2 the carbonation depth is from 25 mm to 70 mm.

*Specimen 0-C2 after phenolphthalein test (carbonation depth 60 – 70 mm)*

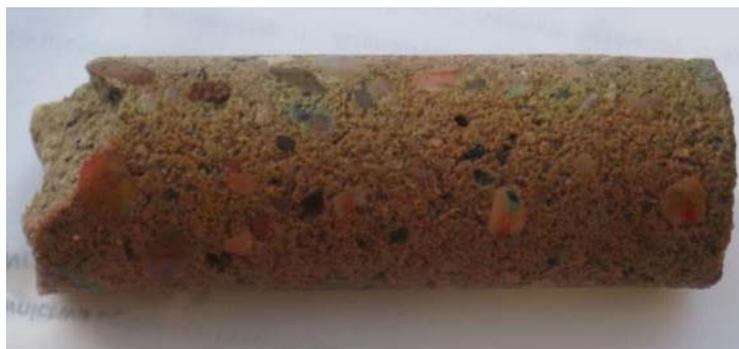
- Sample P1/1 → the layer is carbonated over the entire length of the sample (pH≈5-6) carbonation depth at least **90 mm**,
- Sample P1/2 → the layer is carbonated over the entire length of the sample (pH≈5-6) carbonation depth at least **120 mm**,
- Sample P1/4 → the layer is carbonated over the entire length of the sample (pH≈5) carbonation depth at least **140 mm**,

*Sample P1/1 – carbonation over the entire length of the sample (90 mm - pH≈5-6)*

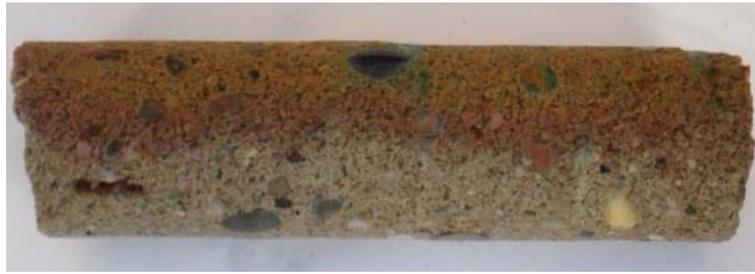
*Sample P1/2 – carbonation over the entire length of the sample (120 mm - pH≈5-6)*

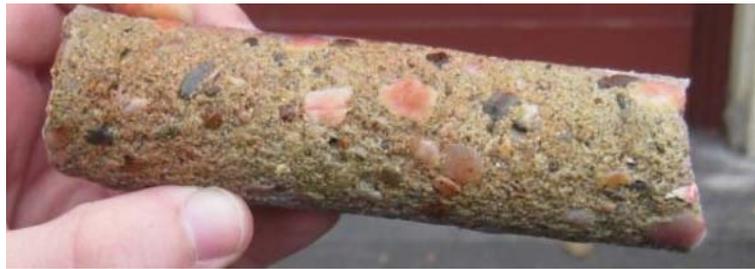
- Sample P2/2 → the layer is carbonated over the entire length of the sample (pH≈ 5) carbonation depth at least **130 mm**,
- Sample P2/3 → the layer is carbonated over the entire length of the sample (pH≈ 5) carbonation depth at least **100 mm**,
- Sample P2/4 → the layer is carbonated over the entire length of the sample (pH≈5-6) carbonation depth at least **180 mm**,

*Sample P2/3 – carbonation over the entire length of the sample (100 mm - pH≈5)*

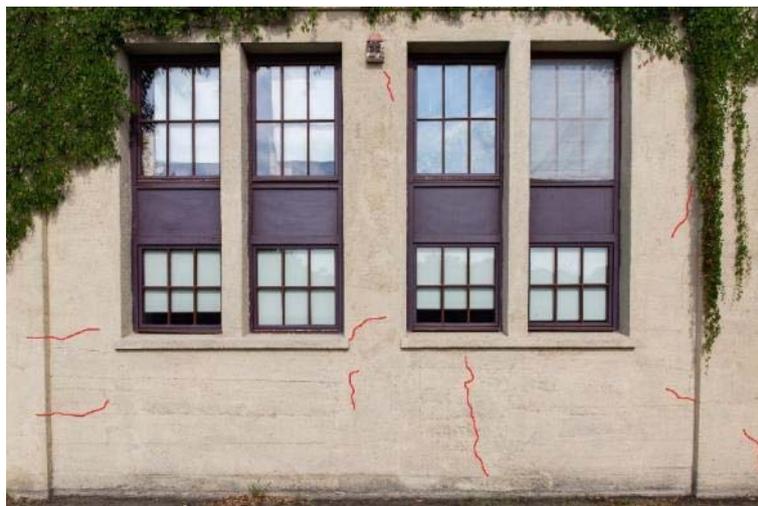
*View of the cracking – P1*

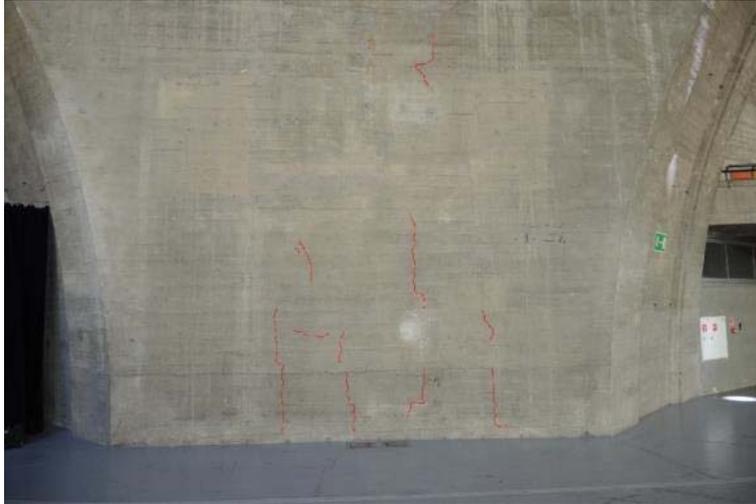
*View of the cracking – P5*

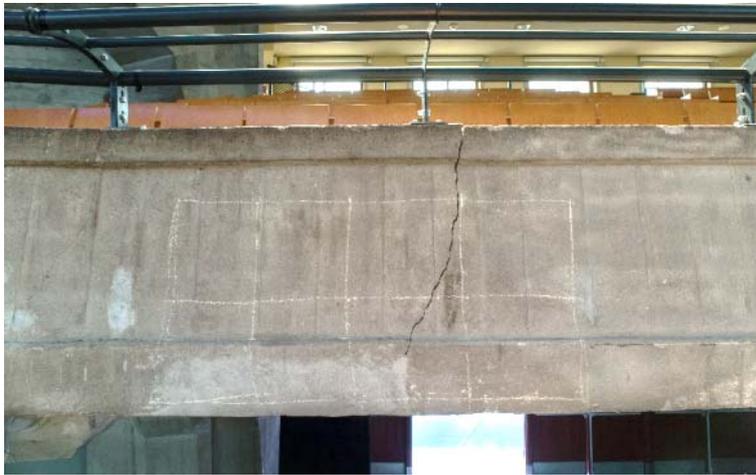
*View of the cracking – P6*

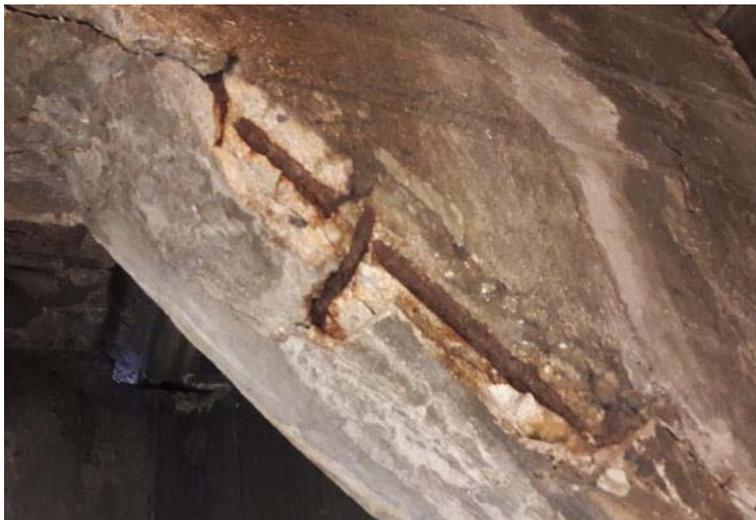
*View of the damages – P7*
