1 Sampling and characterization of the Torricella Peligna War Memorials

1.1 Information on the monument

In Torricella Peligna, two war memorials were chosen as case studies: The Tower and The Angel.

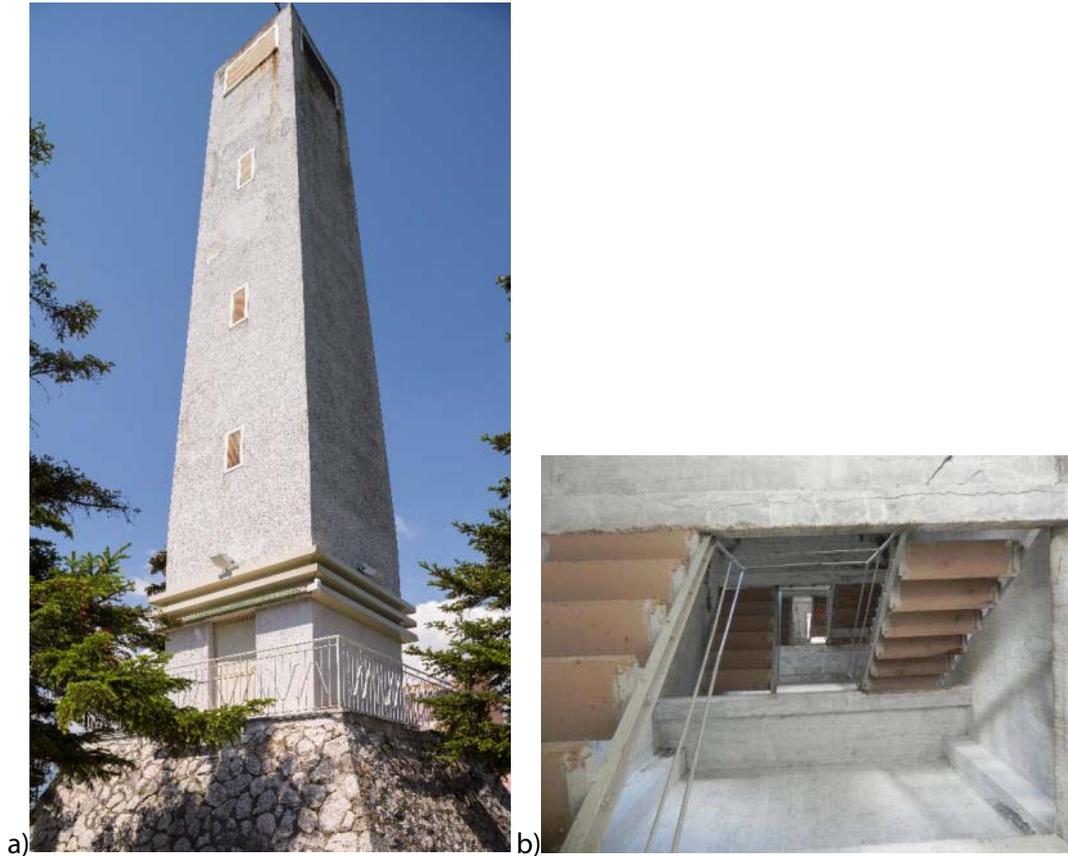
The monument is a truncated pyramid with a squared base. The load-bearing structure is made of a reinforced concrete frame with four decks formed by beams and pillars and 4 round reinforcement rods of 14 cm in diameter at the corners of the pillars and round brackets of 8 cm in diameter with a pitch of 15 cm. The infill walls are also made of in-situ concrete blocks, with dimensions of 15x15x30 cm, laid on horizontal courses with alternating joints in the adjacent rows (Fig. 4.1). The interior is bordered by a series of walkway floors connected by stairs.

Figure 4.1. The Tower War Memorial monument: a) a panoramic view and b) the internal zone.

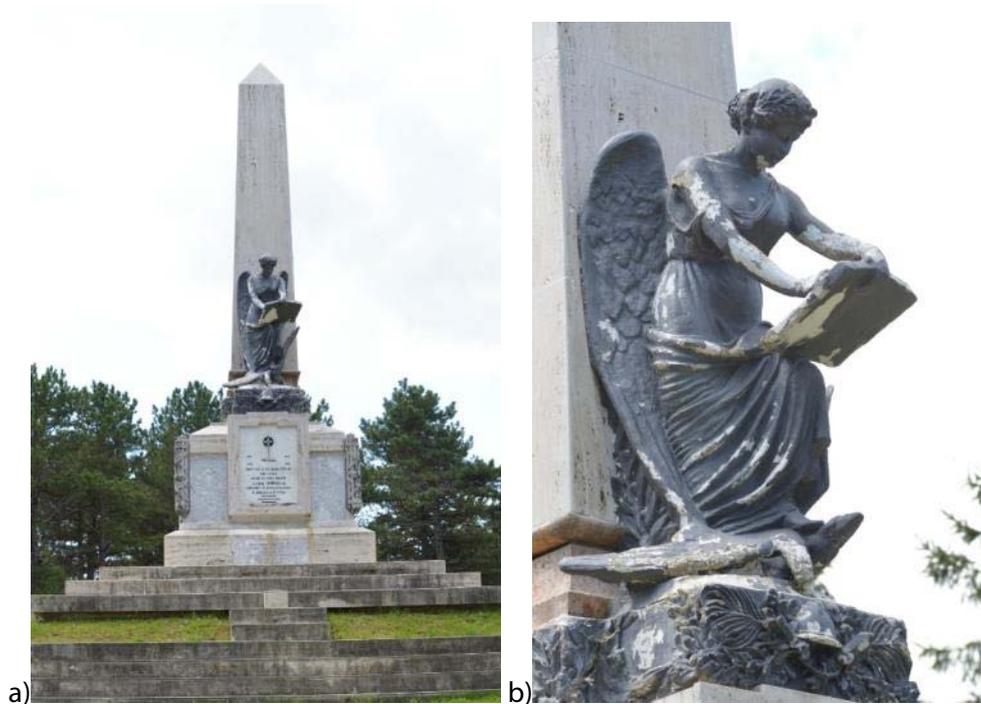
The Angel stands on steps made of stone, it has a quadrangular base with four littori bundles at the corners and an obelisk surmounts it, listing the names of the fallen from Torricella during the Wars. The Angel sculpture in concrete is placed against the obelisk at the front-side looking towards the town. The figure, with classical style female features, has hair that is worn tied back from the face and a wreath of laurel leaves. A strong sense of power is associated with the kindness of the winged figure, depicted while writing the names of the fallen into a golden book. At the same time, she use her left foot to pin down a large eagle, the symbol of the Hapsburg empire, which is struggling to free itself. The monument is the work of N. Lucci from Pennadomo, and was built in 1922. Only a few

Figure 4.2. The Angel War Memorial monument: a) panoramic view and b) the detail of the Angel.

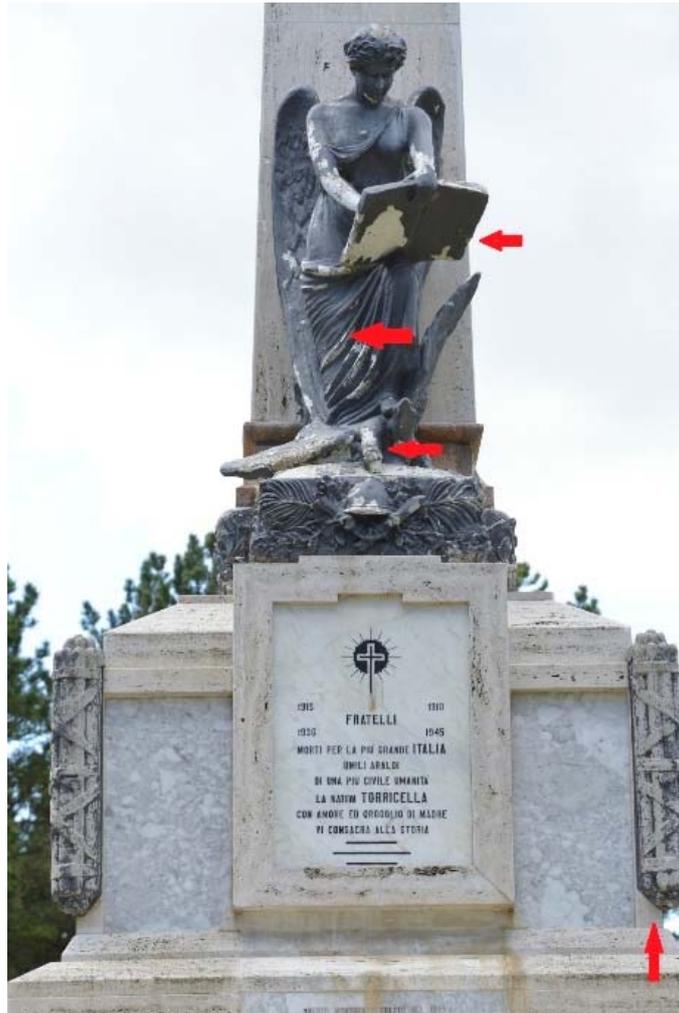
Sample TPA1 - The book presents the most advanced conservation problems, with deep cracks and detachment of the cement material. The rebars are exposed to the environment with intense corrosion products formations. The corrosion, with the consequent increase in volume of the rebars, may be considered to be the main cause of the detachments and deep lesions.

Sample TPA2 - The sample was taken from an area of minimum thickness characterized by widespread micro-cracks and small detachments of material, with deposits of detached surface particles and stagnation of water, without internal metal reinforcement.

Sample TPA3 – The sample was taken from an exposed area characterized by deep micro- and macro-cracks and suffering from leaching from the upper areas. The rebar is exposed and its corrosion has probably contributed to the formation of cracks. The concrete material is disjointed, being devoid of modelling and very badly eroded.

TPA4 sample - The material of the "bundles" is different from that used for the statue, being finer in composition and with better structural conservation characteristics. It is compact and free of cracks.

Figure 4.4. Angel monument: the arrows indicate the positions of the collection of the samples.

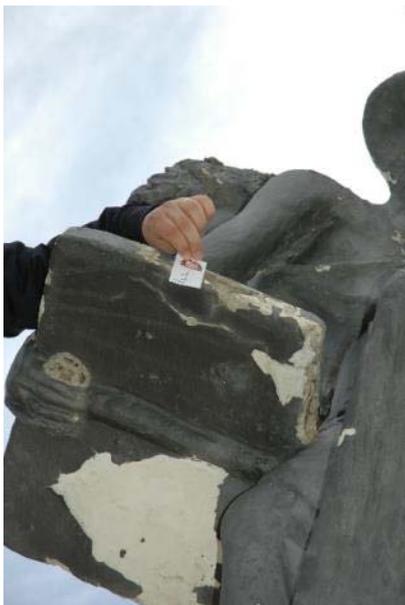
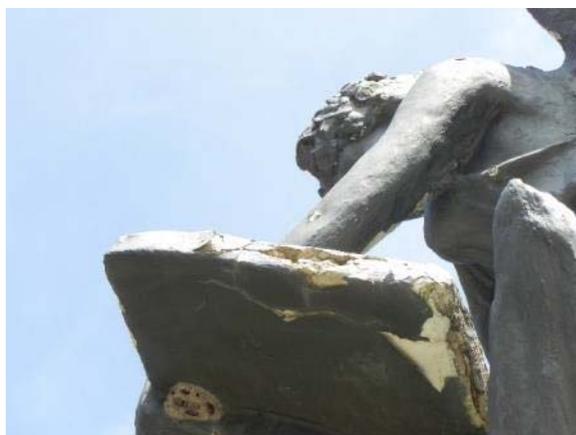
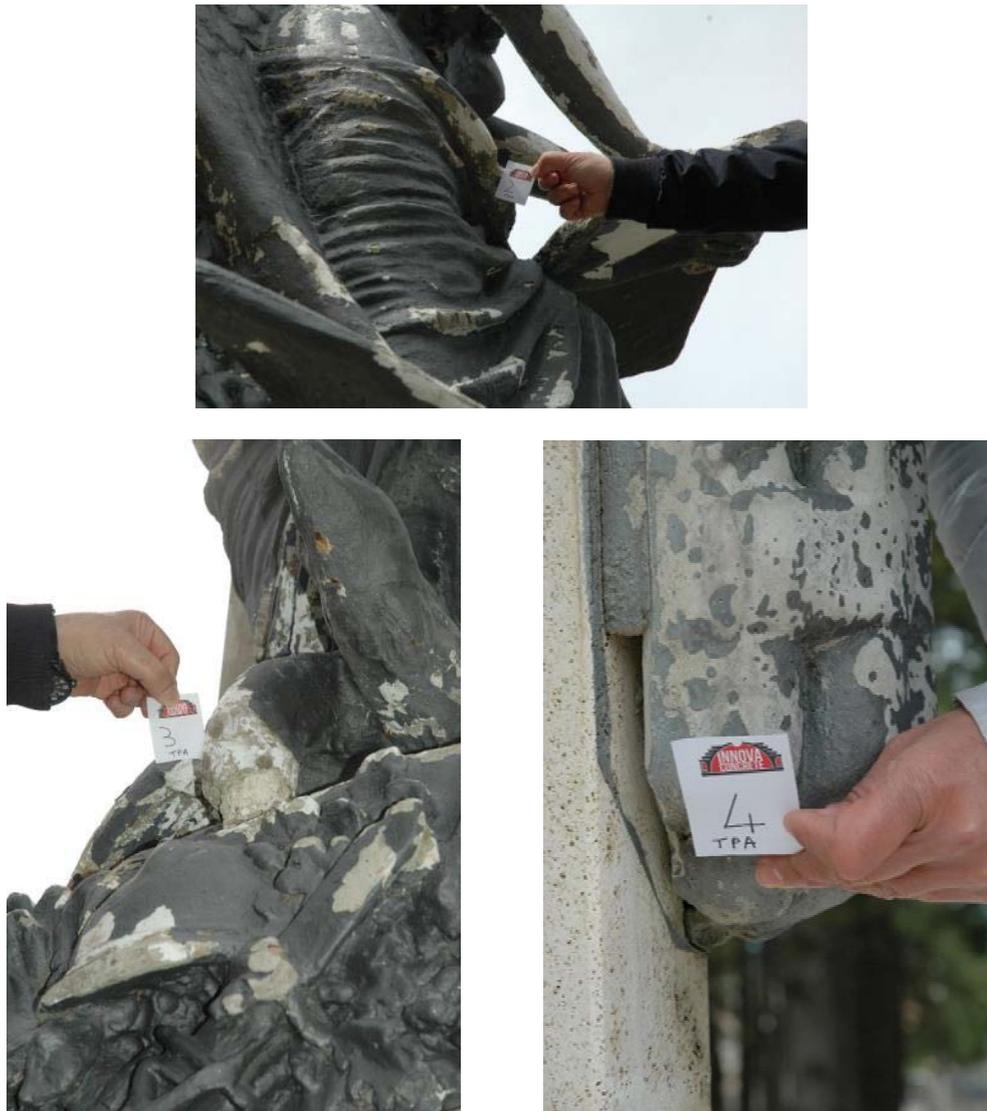
Figure 4.5. The pictures show the details of sampling.

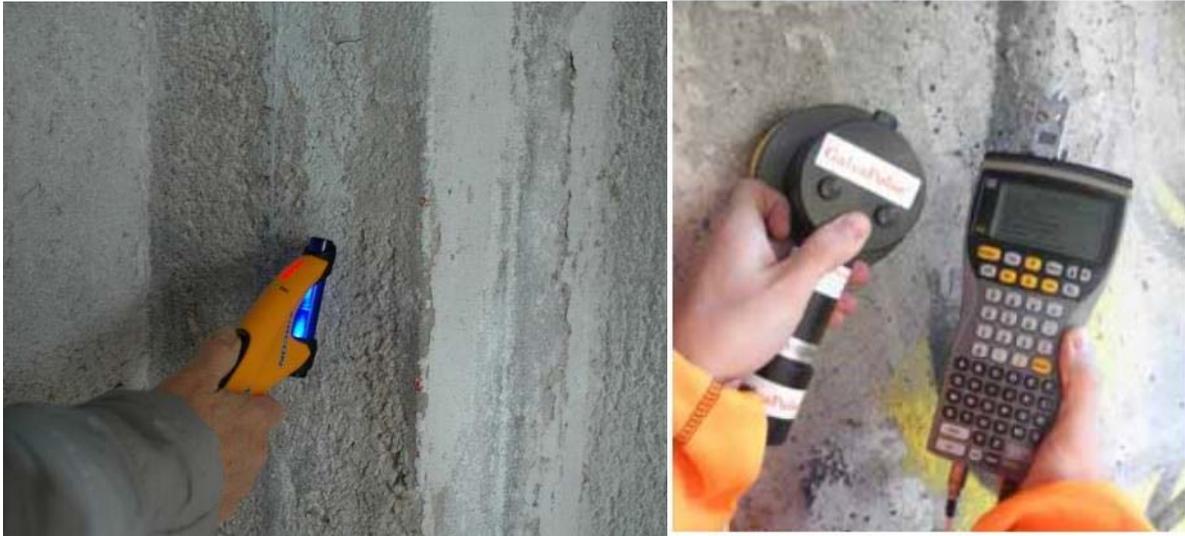
Figure4.23. Pictures during the detection of reinforcement position and during the measurements with the GalvaPulse instrument.

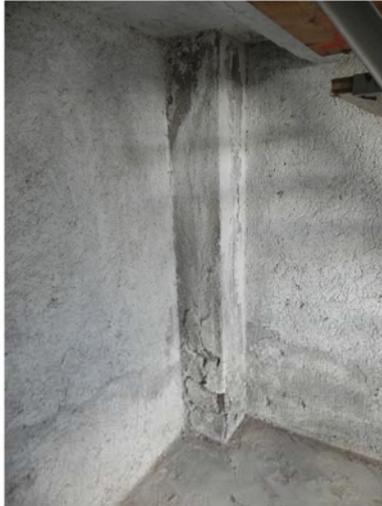
Figure 4.24. Picture of the internal pillar n. 1 of the Tower, the location inside the Tower, 2D plot of potential and corrosion rate values determined by in situ measurements, table with potential, corrosion rate and resistance values in the different X and Y positions at the wall grid.

From the corrosion rate map of pillar 1, a high corrosion activity is observed in the throughout measured area (only a value is out of the range). Regarding to pillar 2, the corrosion activity is moderate in all the measurement area with the exception of point 1;2 in which it is high.

Values in the table: Potentials mV vs. Ag/Ag/Cl
Corrosion rate $\mu\text{m}/\text{year}$
Resistance KOhm

Whether condition T 13°C, Rain
Grid space used 15 x 15cm
Steel reinforcement area: 3519 mm²
Method of measurement: Galva Pulse

In the Tower, simultaneous measurements of half-cell potential (Ag/AgCl), corrosion rate and electrical resistance of the three pillars were carried out using the GalvaPulse. In all the three pillars the concrete cover is 2-3 cm thick.

The identification of the corrosion activity was performed according to the literature [T. Frolund, 2002 (with GalvaPulse Instrument)]. The relationship between the corrosion rate values and the corrosion activity is the following:

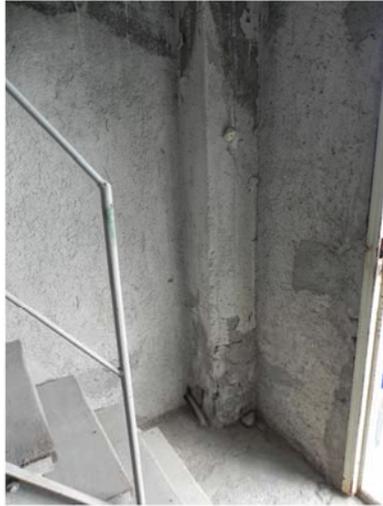
Figure 4.25. Picture of the internal pillar n. 2 of the Tower, the location inside the Tower, 2D plot of potential and corrosion rate values determined by in situ measurements, table with potential, corrosion rate and resistance values in the different X and Y positions at the wall grid.

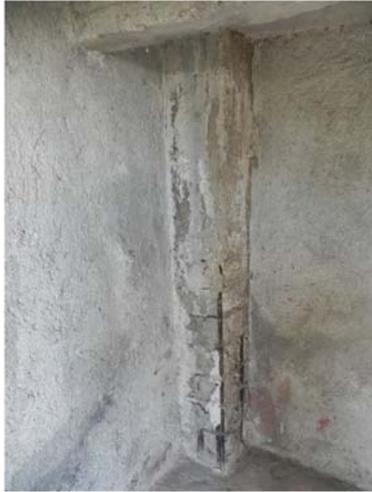
At a visual inspection, the pillar 3 shows an advanced degradation state with deteriorated concrete cover and partially exposed and corroded bars. These observations are confirmed by the electrochemical measurements that record a high corrosion activity. A possible correlation between the corrosion activity and the Tower's geographic exposure is observed. In fact, pillars 1 and 3, respectively exposed to North and West, are more degraded compared to pillar 2 exposed to the East.

Figure 4.26. Picture of the internal pillar n. 3 of the Tower, the location inside the Tower, 2D plot of potential and corrosion rate values determined by in situ measurements, table with potential, corrosion rate and resistance values in the different X and Y positions at the wall grid.

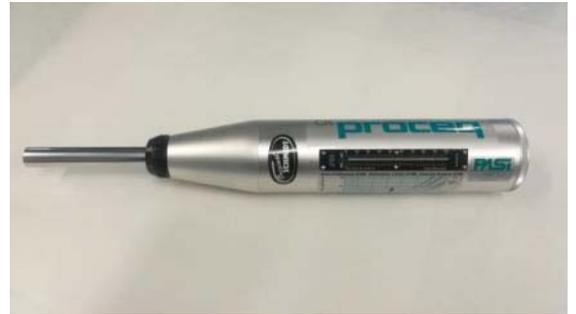
A steel hammer impact, with a predetermined amount of energy, a steel plunger in contact with a surface of concrete, and the distance that the hammer rebounds is measured.

The device consists of a plunger rod and an internal spring loaded steel hammer and a latching mechanism. When the extended plunger rod is pushed against a hard surface, the spring connecting the hammer is stretched and when pushed to an internal limit, the latch is released causing the energy stored in the stretched spring to propel the hammer against the plunger tip. The hammer strikes the shoulder of the plunger rod and rebounds a certain distance. There is a slide indicator on the outside of the unit that records the distance traveled during the rebound. This indication is known as the **rebound number**. By pressing the button on the side of the unit, the plunger is then locked in the retracted position and the rebound number (R-number) can be read from the graduated scale. A higher R-number indicates a greater hardness of the concrete surface. The tests can be performed in horizontal, vertically upward, vertically downward or any intermediate angled positions in relation to the surface.

The rebound hammer test also known as Schmidt Hammer Test developed by Swiss engineer Ernst Schmidt in 1948 is one of the oldest, simplest and most popular non-destructive tests of concrete. The device uses a spring and measures the hardness of concrete surface using the rebound principle. The rebound hammer test is codified in ASTM C805, and CSN EN 12504-2.

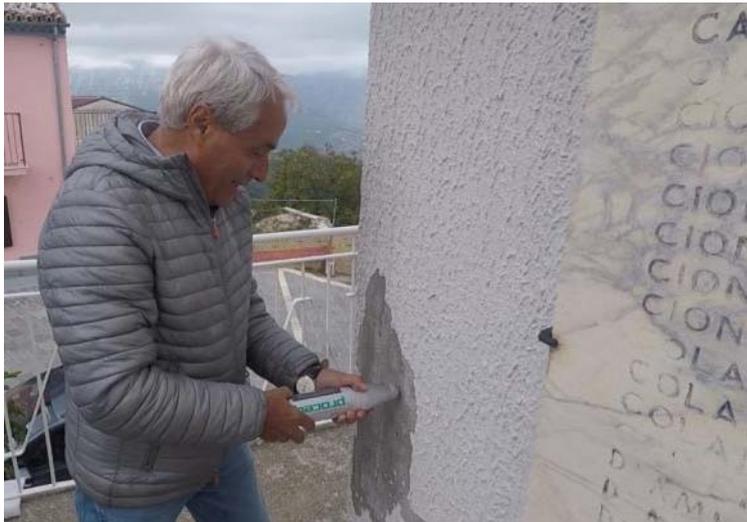
Fig. 4.27. Application of the Schmidt hammer device on the external wall of the monumental test site

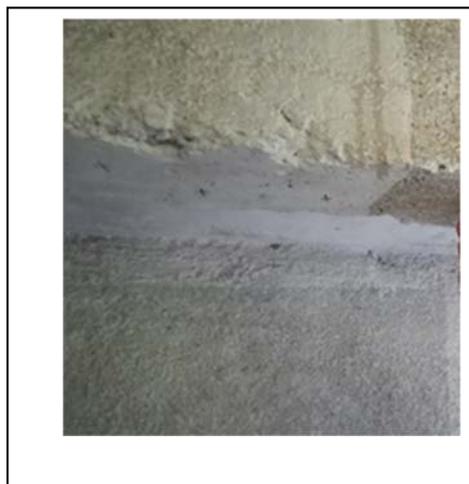
Conversion curves for rebound type N and L (for cubic sample)

L1	28
L2	19
L3	24
L4	28
mean	24.75
st dev	4.27
N1	30
N2	30
N3	30
N4	31
mean	30.25
st dev	0.50

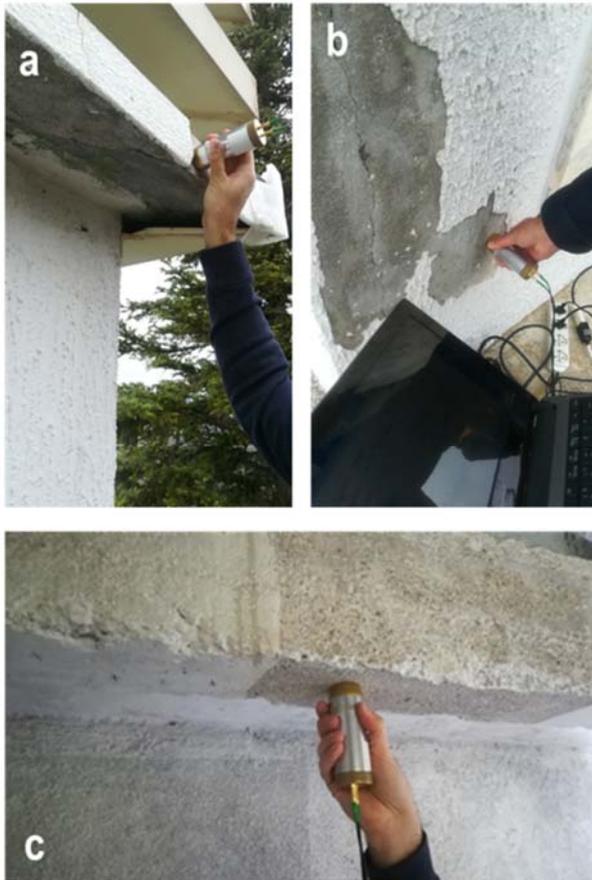
Figure 4.28. Application of the SUSI system on the external wall of the monumental test site (a) and (b), and in the internal parts (c).

The measurements of MC and SI by the SUSI instrument presents an increasing trend in moisture content from the bottom level to upward. This is phenomenon is clear from the results on the internal wall rear pillar on the corner North/East.

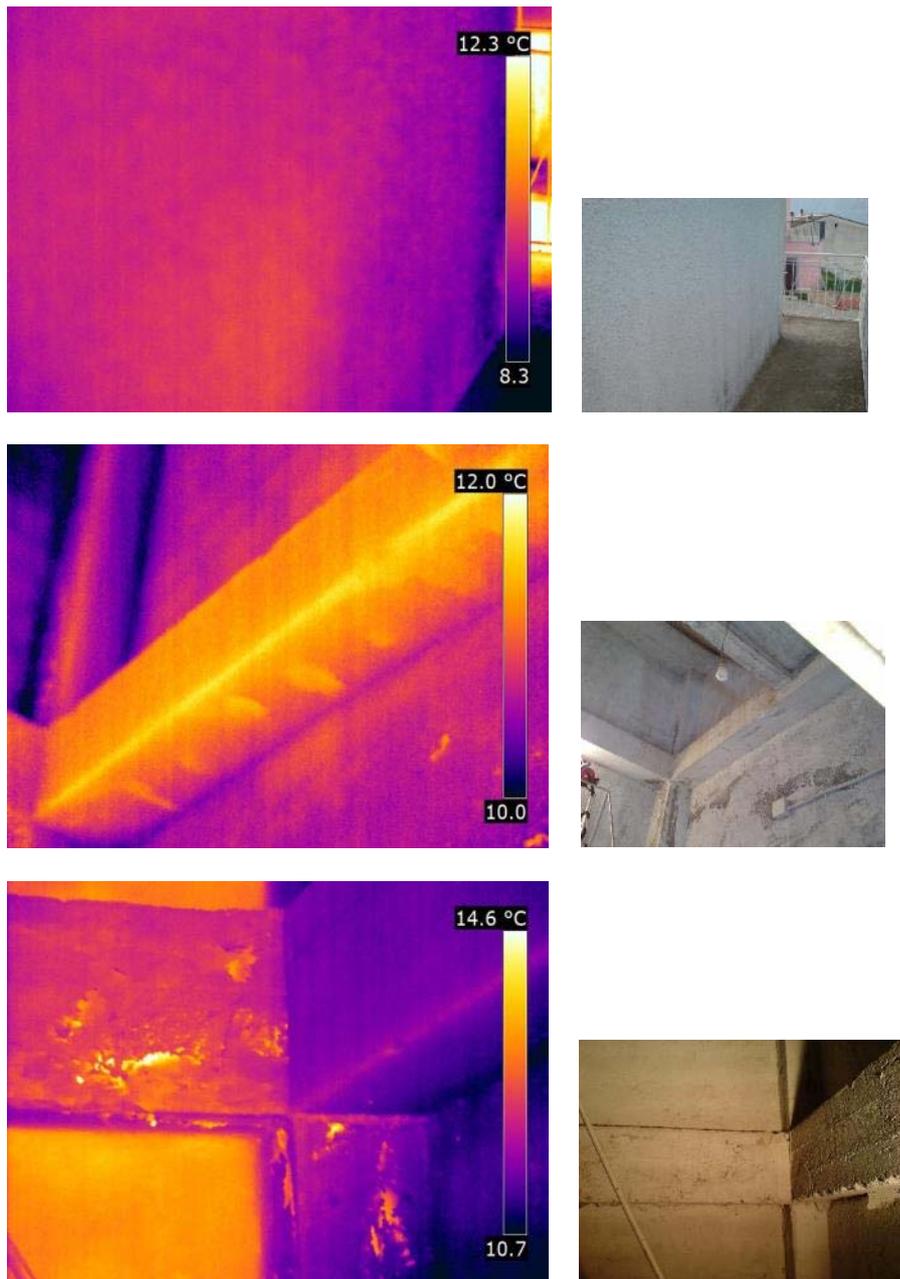
Although, from a general overview, the monument may seem to be in a reasonable state of conservation (Fig.4.31), scientific investigation confirms what may already be noted by careful visual observation – that there are significant detachments of portions of plaster, from past maintenance work which aimed to renovate certain areas of wall-edges and smooth walls. A series of significant sites of vertical damage (lesions) were found, which were especially concentrated at the corners of the first level in correspondence to the concrete detachment from the pillars. At the bottom of the Tower, the significant presence of dampness was detected, which has contributed significantly to the degradation of concrete and reinforcements. The formation of structural macro-cracks was observed. Another critical situation was found, by thermographic survey, at the top of the monument, which is probably due to complete exposure to weathering agents. Both these critical areas (the first and last levels) have serious problems that can be detected both externally and internally. The decay processes have generated damages and cracks which are critical for the conservation of the monument.

Figure 4.31. Thermographic analyses

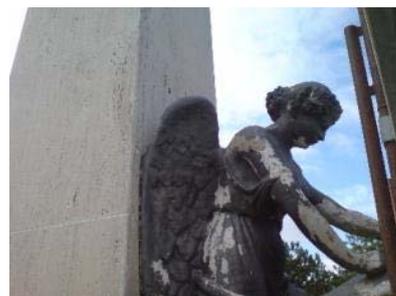
Thermographic surveys have revealed that the layers of paint have created a barrier to reaching the deepest layers, in some cases altering the reading of the results, but demonstrating the insulating action of the paint. Both the wings and the head of the eagle, at the base of the statue, show deep concrete detachments, probably due to the oxidation of the reinforcements and to the use of poor materials. The book had very deep lesions in the upper and lateral part with loss of material leaving the reinforcements uncovered. The damages are concentrated mainly in the areas which are most exposed to weathering, that have micro- and macro-lesions. The degradation of the cement material is evident in all parts of the memorial (Fig. 4.32).

Figure 4.32. Some results of thermographic investigations

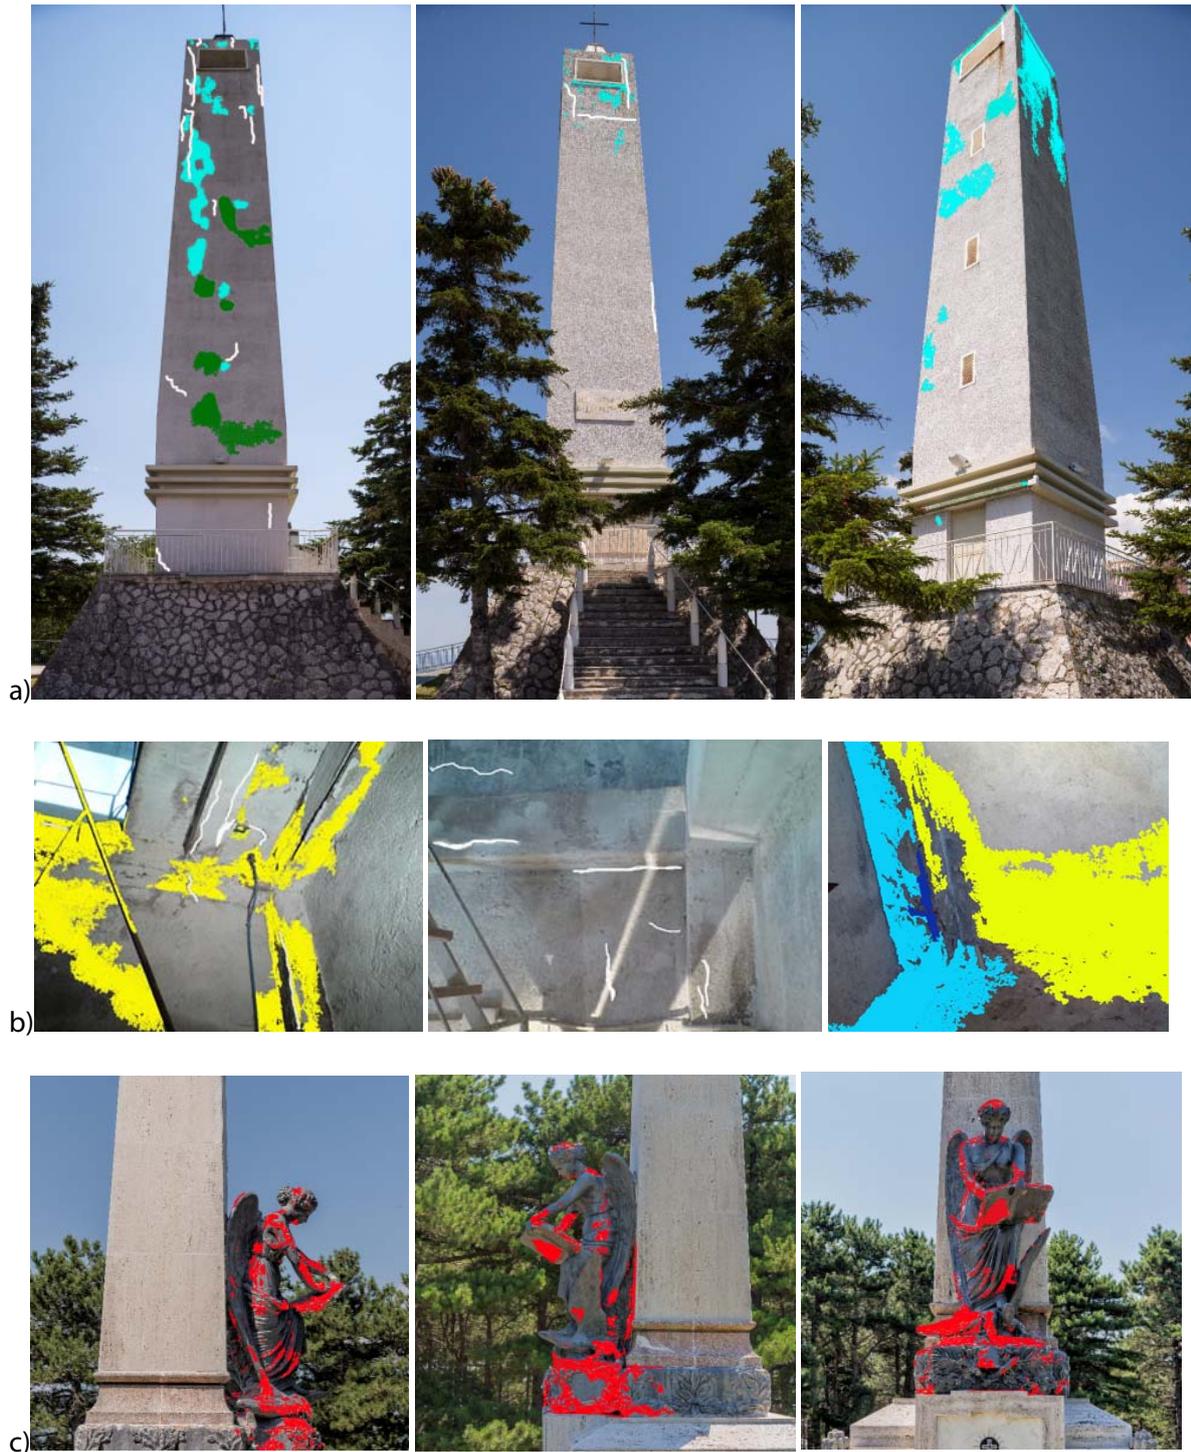
The external surface of the Tower shows the presence of some alterations, whereas in the internal area it can be clearly observed the presence of detachments, salt efflorescence, humidity and cracks.

In the Angel, the surface painting is very degraded throughout all the statue, thus allowing the infiltration of water inside concrete. Signs of alterations are evident, such as biological patina, cracks, detachments and steel corrosion. The surface painting has probably a not positive effect of the state of conservation.

Figure 4.33. Maps of damages: a) external of Tower; b) internal of Tower; c) Angel
