# 1 Sampling and characterization of the Flaminio Stadium

## 1.1 Information on the monument

## 1.2 Sampling activities

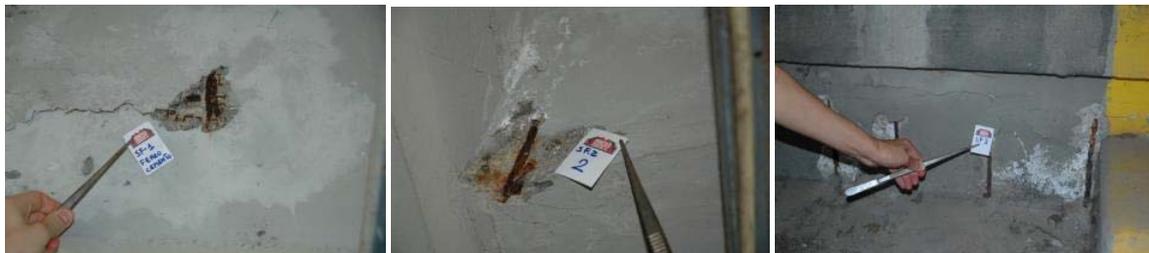
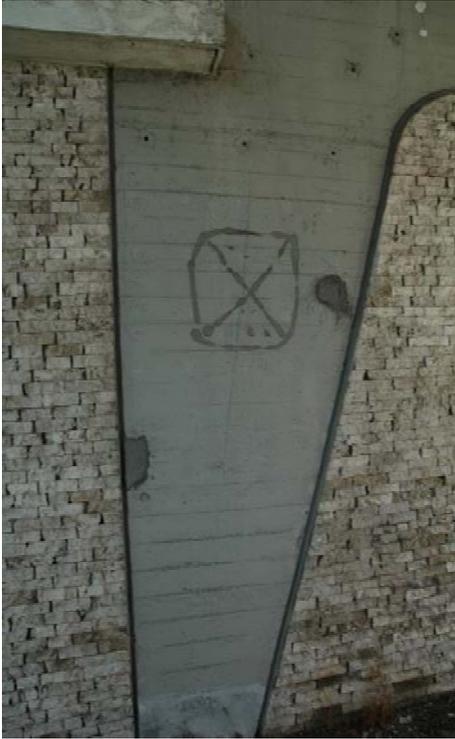
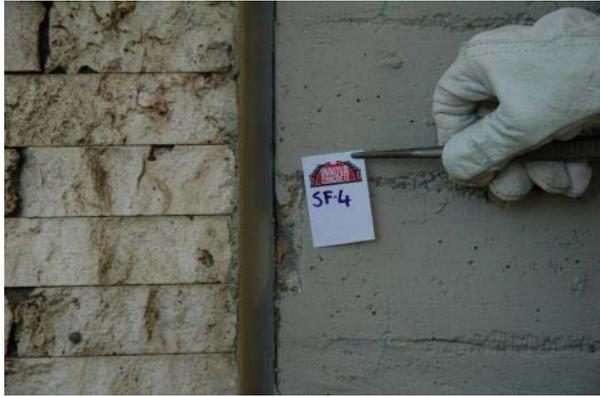
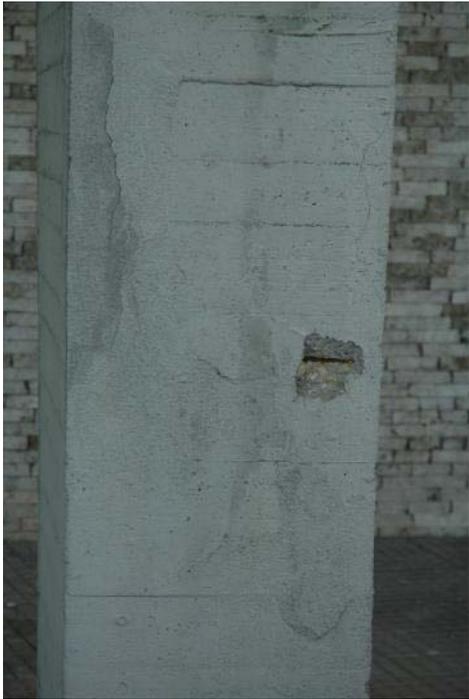
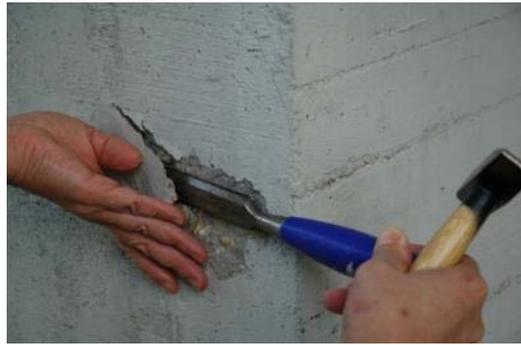
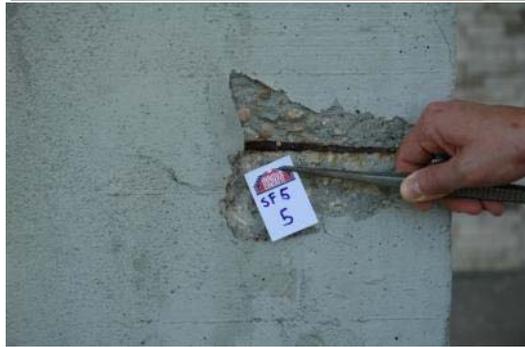
Figure 9.2. The photos show the samples collected and their position.

Sample SF1 – SF2: the sampling area of the canopy in ferro-cement showed concrete detachments, corroded rebar and presence of moisture caused by water infiltration.

Sample SF3: the area below the grandstand suffered from salts efflorescence and corroded rebar with detachments of cement material.

Sample SF4: the sampling area did not seem to be affected from degradation processes. The samples was collected in order to compare data from a previous characterisation of the pillar performed during an earlier measurements campaign.

Sample SF5: The pillar was subject to water infiltration from the above structure and exhibit corroded rebar with partial detachment of the concrete.

Sample SF6: Area selected from a surface exposed to weathering.

Sample SF7: The sampling area is located on the south part of the stadium and it appeared to be affected by erosion and concrete detachment.

Sample SF8 –SF9: the area presented internal problems of humidity and external problems of water infiltration.

Sample SF10b: the area showed water infiltration from the above structure and contact stress of adjacent metal barrier.

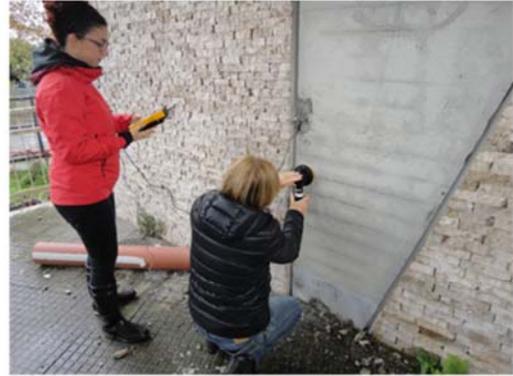
Corrosion rate values related to the external concrete pillar n. 73 show that the corrosion activity is negligible for all the investigated area. Moreover, in agreement with the visual inspection, the rebars still have the surface passivation layer. It should be remembered that in this site the concrete cover is very thick (about 4 cm) and has probably protected the reinforcement from weathering.

Figure 9.11. Picture of the external pillar n. 73 of the Flaminio Stadium, 2D plot of potential and corrosion rate values determined by in situ measurements, table with potential, corrosion rate and resistance values in the different X and Y positions of the surface grid.

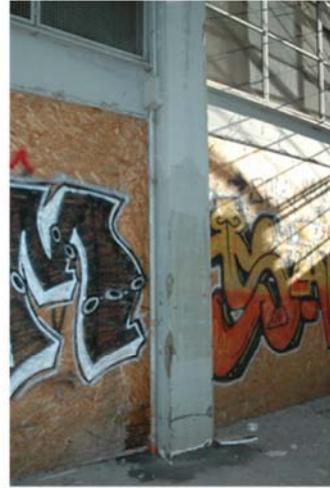
Corrosion rate values related to the external pillar n. 9 show that also in this case the corrosion activity is negligible, similarly to the pillar n. 73. The rebars are also passivated.

Figure 9.12. Picture of the external pillar n. 9 of the Flaminio Stadium, 2D plot of potential and corrosion rate values determined by in situ measurements, table with potential, corrosion rate and resistance values in the different X and Y positions of the surface grid.

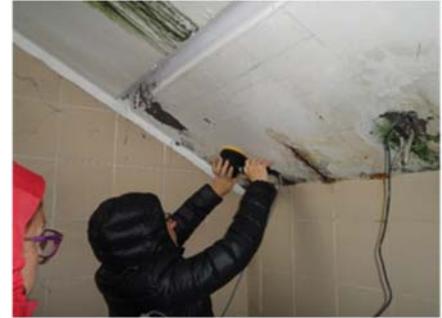
From the corrosion rate map of the internal frame n. 28-29, it was observed that the left side of the wall shows a corrosion activity from moderate to high values with a peak at the bottom left corner. On the contrary, in the right side the corrosion activity is from moderate to low. Probably this difference is caused by the geometry of the prefabricated reinforced concrete that facilitates the stagnation of water at the corner elements.

Figure 9.13. Picture of the internal concrete frame n. 28-29 of the Flaminio Stadium, 2D plot of potential and corrosion rate values determined by in situ measurements, table with potential, corrosion rate and resistance values in the different X and Y positions of the surface grid.

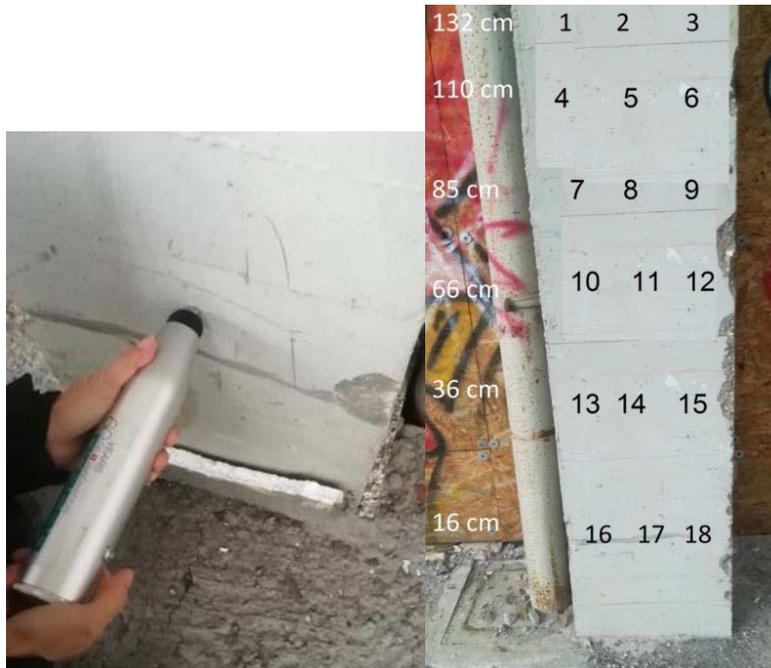
**Pillar 8 external**

Cm from ground	number	sx	cent	dx
132	1_2_3	50	52	52
110	4_5_6	49.5	50.5	51
mean		51.1		
st dev		0.89		
Kg/cm2		750	± 80	
MPa		<b>73.5</b>	± 7.8	
92	7_8_9	50	51	48
70	10_11_12	52	50	48
mean		49.8		
st dev		1.60		
Kg/cm2		720	± 80	
MPa		<b>70.6</b>	± 7.8	
42	S1_2_3	50	47	48
24	S4_5_6	46	48	48
mean		47.8		
st dev		1.33		
Kg/cm2		680	± 80	
MPa		<b>66.6</b>	± 7.8

R
<b>mean</b>	49.5
<b>st dev</b>	1.85
<b>Kg/cm2</b>	720 ± 80
<b>MPa</b>	<b>70.6</b> ± 7.8

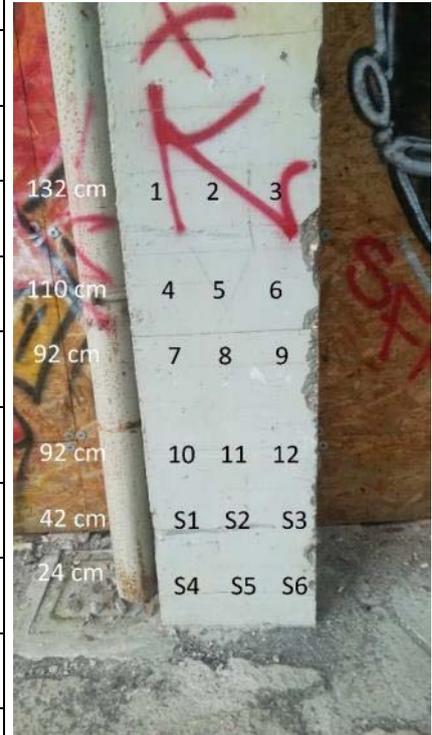
### Pillar 8 external

Distance from ground [cm]	number	Moisture content			
		sx	cent	dx	media
132	6S	2.2	2.2	2.0	<b>2.1</b>
110	5S	0.8	2.2	1.6	<b>1.5</b>
92	4S	1.6	2.2	1.6	<b>1.8</b>
70	3S	2.2	1.6	2.2	<b>2.0</b>
42	2S	1.6	1.4	1.4	<b>1.4</b>
24	1S	2.0	2.2	2.8	<b>2.3</b>

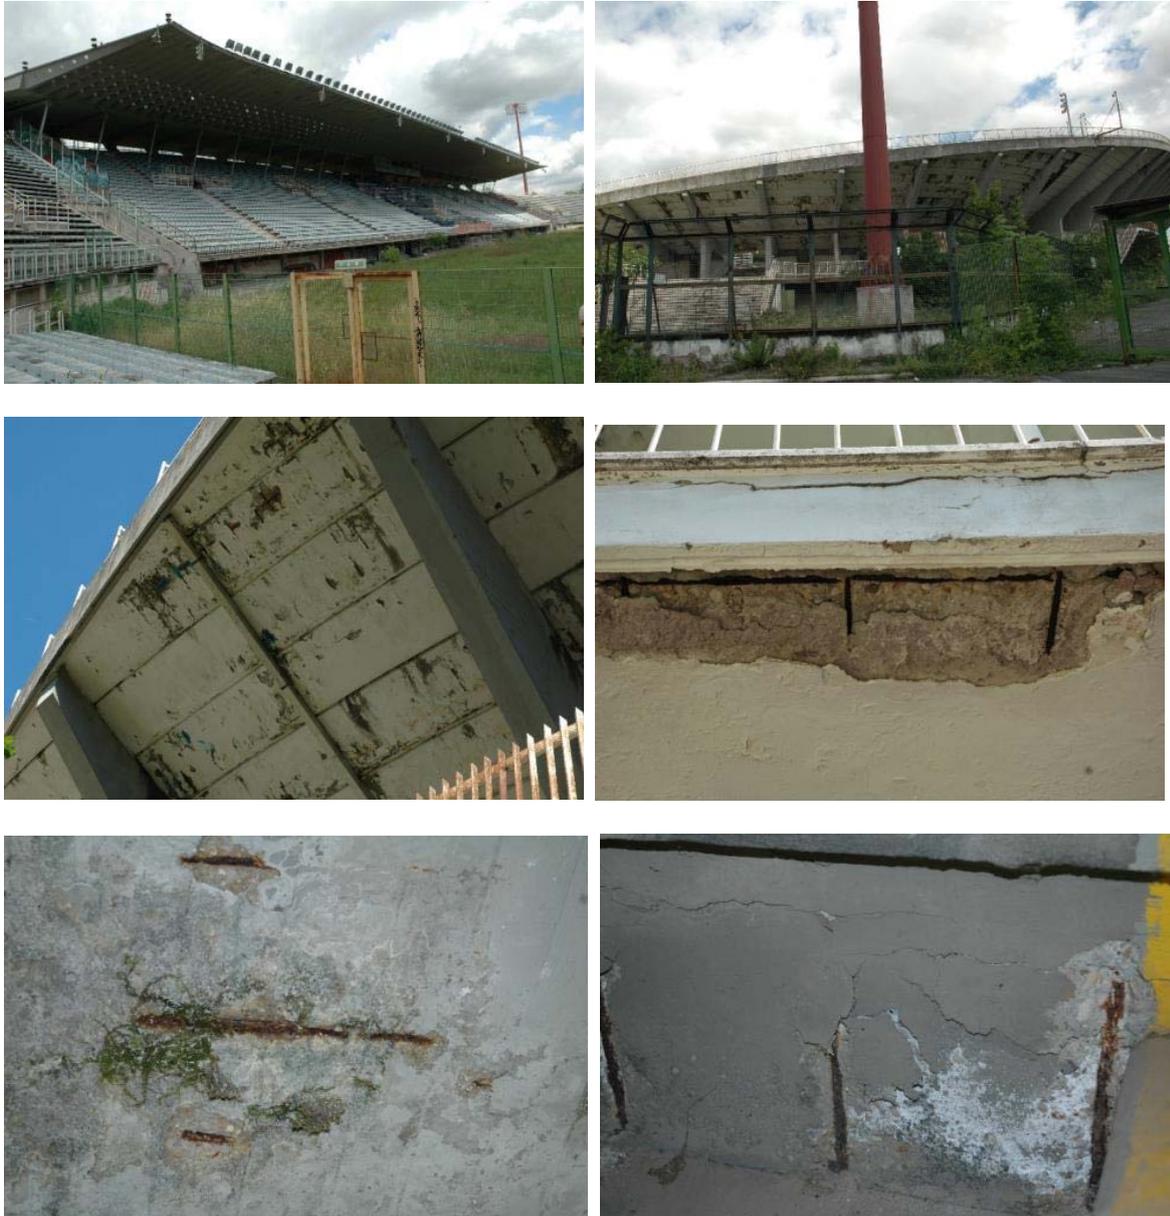
The Flaminio Stadium is now in a serious state of degradation since it was abandoned for years (Fig. 9.15). The decay processes are mainly due to improper interventions that failed to respect the characteristics of the original structure, widespread deterioration caused by years of neglect and the physiological aging of the materials.

The damages are mainly due to water infiltration into concrete structure and to the notable formation of biodeteriogens such as algae and fungi. Salt efflorescence is visible in some parts of the structure and contributes to the deterioration of concrete. However, the results of the characterizations confirm that the concrete pillars are still in a good state of conservation with a

medium-high consistency of concrete and steel reinforcements. The pictures below show the major degradation problems that were observed in some areas of the stadium, mainly due to the lack of appropriate maintenance actions and to a not optimal drainage of water probably caused by the improper interventions.

Figure 9.15. Panoramic view and details of the state of conservation of the Flaminio Stadium.

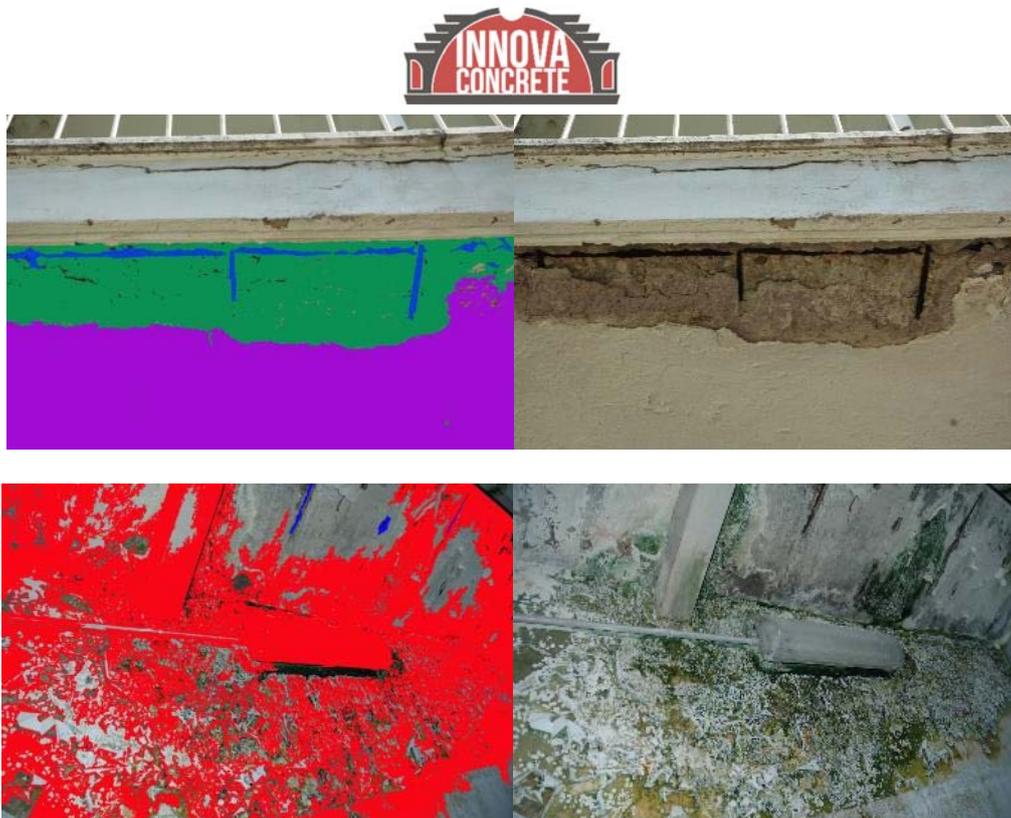
The pictures in figure 9.16 show the most advanced types of degradation in the different areas of the monument.

Red: water infiltration, formation of biodeteriogens, detachments and iron corrosion;

Blue: corrosion of metal reinforcement;

Yellow: salt efflorescence;

Green: detachments of concrete material;

Violet: damp areas.

Figure 9.16. Damage maps in panoramic view and in details of the Flaminio Stadium.

The definition of an appropriate conservation plan is mandatory to preserve this concrete monument. The Flaminio Stadium has been now listed, thus recognizing its unique value. The application of the InnovaConcrete products based on consolidants and corrosion inhibitors can play a key role in the preservation of this monument and in the inhibition of degradation processes. The application of products with superhydrophobic properties can also have a relevant role in the inhibition of degradation processes due to water infiltration and in the conservation of this monument.
