1 Sampling and characterization of the Warsaw Railway Station

The following paragraphs summarize the main findings and information regarding the sampling and characterization of the Śródmieście WKD Station Pavilion, one of the case studies chosen as part of INNOVACONCRETE project.

1.1 Information on the monument

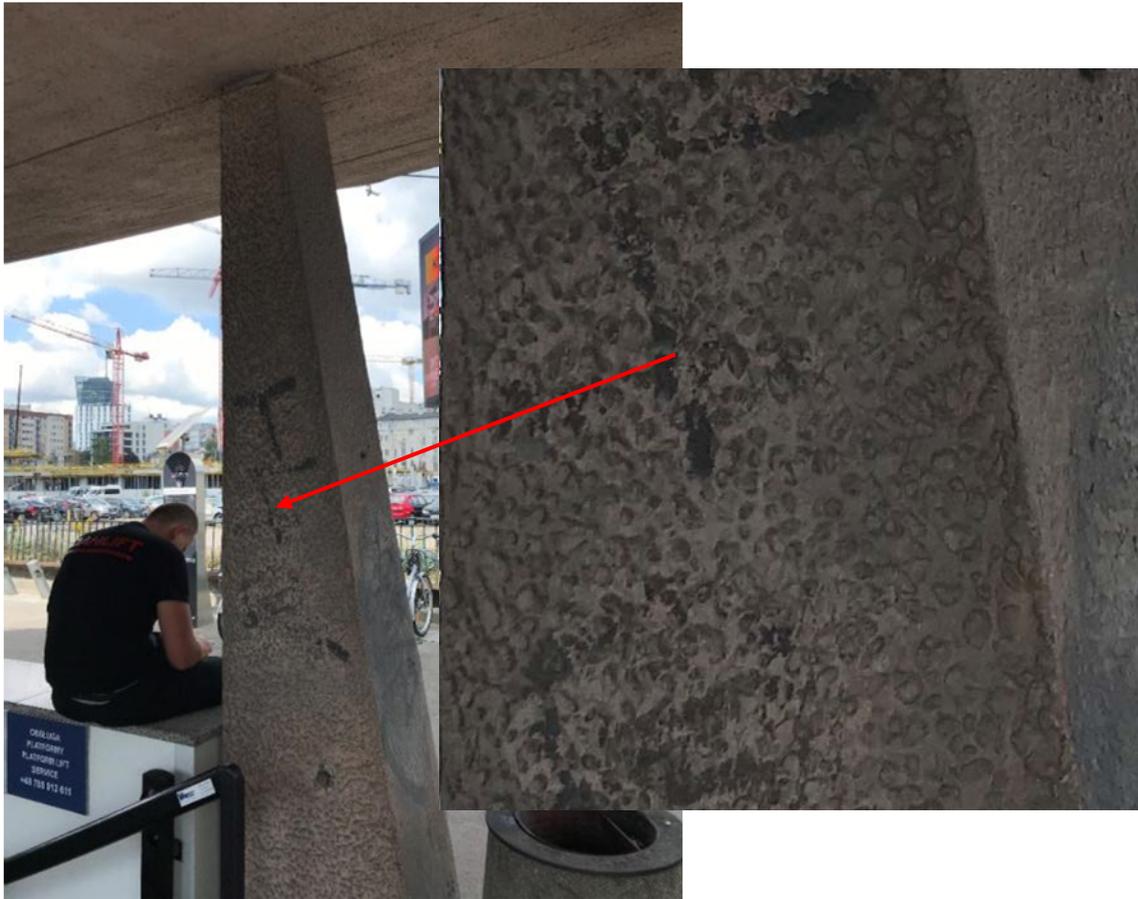
Figure 7: Srodmiescie WKD Station Pavilion columns detail. Source: INES Ingenieros 2018.

See Figure 7, showing graffitis on one of the structure columns. The structure has been recently painted, covering most of the existing graffitis.

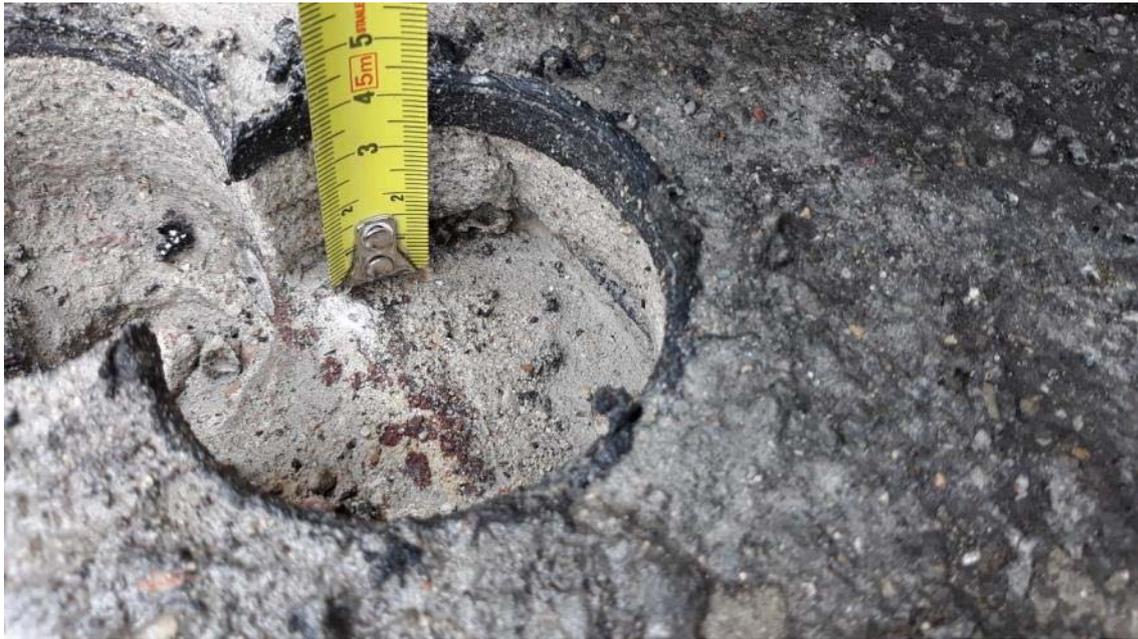
The main horizontal structural element is the pavilion deck, designed as a hyperbolic paraboloid thin-shell of variable thickness from 8 cm to 20 cm thick, built in reinforced concrete. This shell structure has got a waterproofing treatment on the top face based on a bituminous layer, which thickness goes from 4 mm on the edges to 10 mm in the centre. The bottom layer is left of concrete with any treatment.

Figure 8: Srod miescie WKD Station W-D5 test, with the measurement of the waterproofing layer thickness in the centre of the deck. Source: INES Ingenieros 2018.

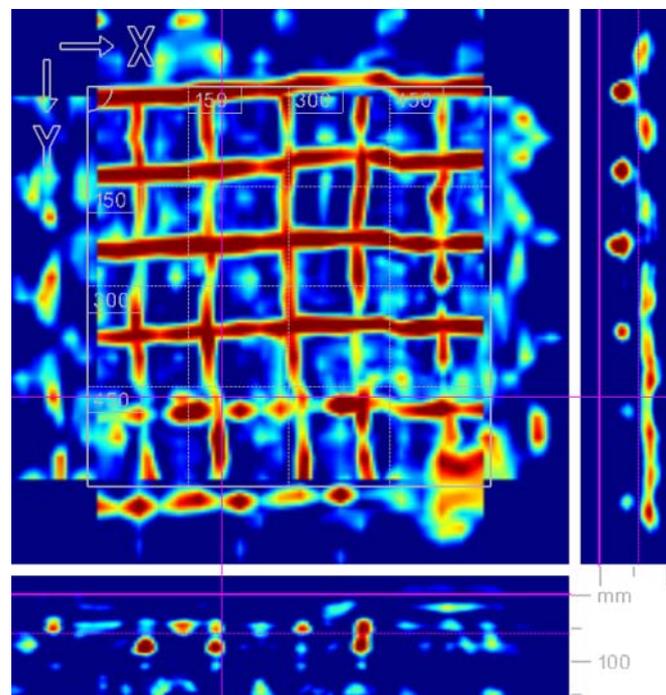
The deck has got a mesh reinforcement, with bars every 15 cm in both directions. The concrete covering for this element varies in the different measurements, reaching values of even 3 mm and never over 27 mm, which is under the 35 mm minimum concrete covering required by the Eurocode Standards for the environment the structure is subject to.

Figure 11: Srod miescie WKD Station Pavilion deck X-Scan measurement, showing reinforcement mesh and concrete covering. Source: INES Ingenieros 2018.

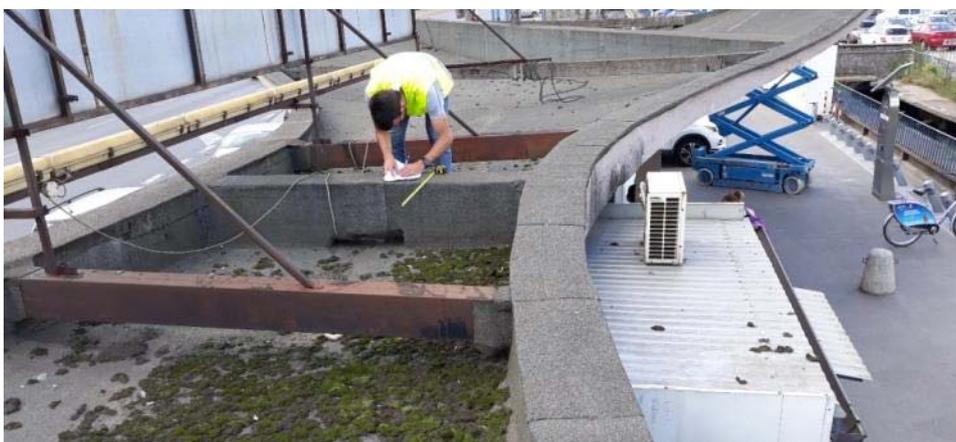
- **Lichens and fungus high concentration area**

Figure 33: Lichens and fungus in Srodmiescie WKD Station Pavilion deck top face. Source: INES Ingenieros 2018.

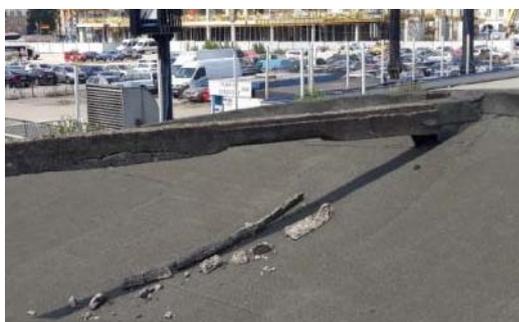
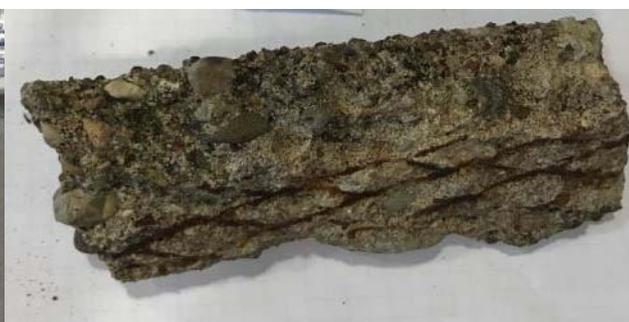
Besides these destructive samples obtained by drilling, the team could obtain extra samples of concrete from existing fallen pieces found in the top surface of the structure deck. These were used to analyse if the concrete contains any sulphates or chlorides by conducting salt extraction tests and using X-Ray diffraction and scanning electron microscope techniques.

Figure 40: Fallen concrete sample from Srodmiescie WKD Station Pavilion bracing beam. Source: INES Ingenieros 2018.

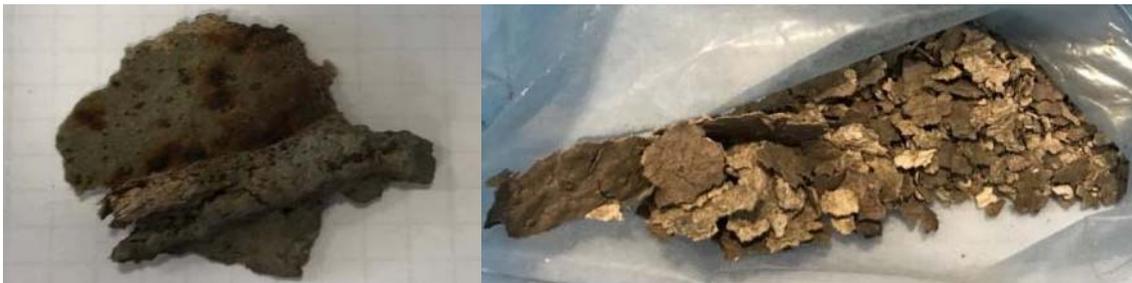
Figure 42: Black crust and peeling samples from Srodmiescie WKD Station Pavilion thin-shell. Source: INES Ingenieros 2018.

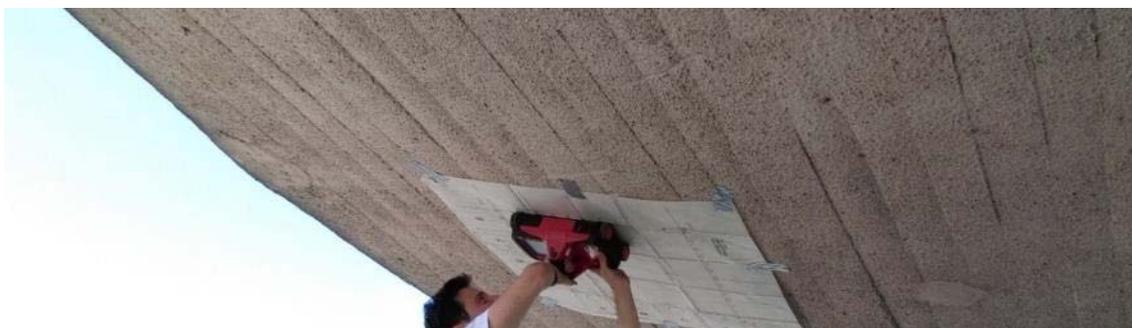
These were oriented to determine the concrete cover (thickness of concrete protecting the reinforcement or structural steel from corrosion) available in the different areas as well as for detecting those locations without reinforcement to enable the drilling to be conducted.

Figure 43: X-Scan measurements from Srod miescie WKD Station Pavilion thin-shell bottom face. Source: INES Ingenieros 2018.

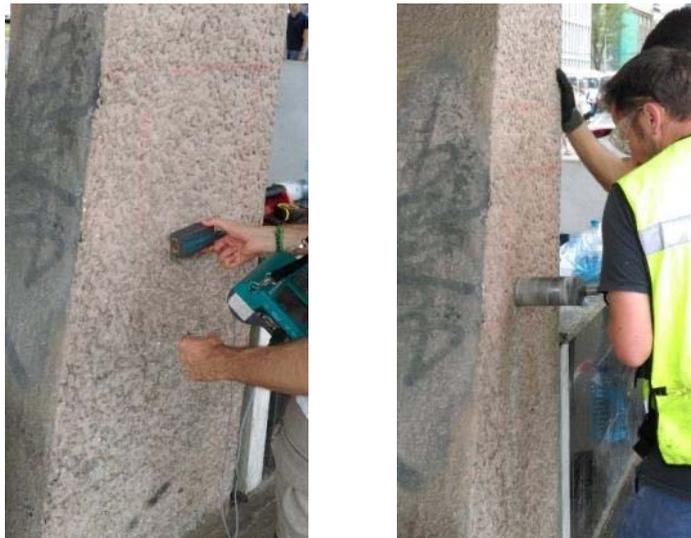
Figure 44: Pachometer measurements from Srod miescie WKD Station Pavilion columns. Source: INES Ingenieros 2018.

From the 13 X-Scan measurements undertaken during the field survey, none had more than 20 mm of concrete covering. This is understandable for the thin-shell structure used as deck but the rest of the concrete elements have dimensions that would allow having the minimum concrete cover required by the Standards. Thus, it is a construction or project definition failure.

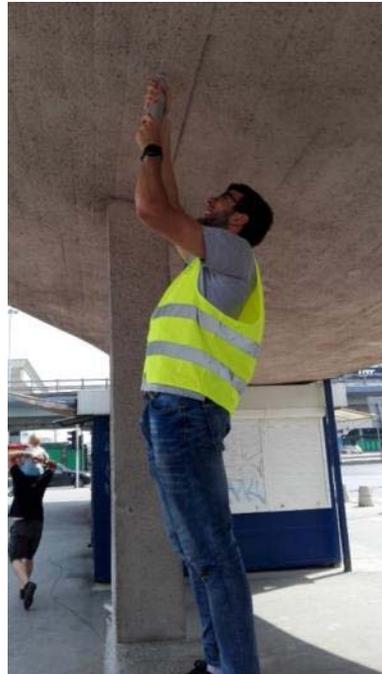
Figure 45: Schmidt hammer measurements from Srodmiessie WKD Station Pavilion thin-shell bottom face. Source: INES Ingenieros 2018.

As explained in Annex 6.3, each measurement is composed of 10 readings to have a reliable result based on statistical analysis.

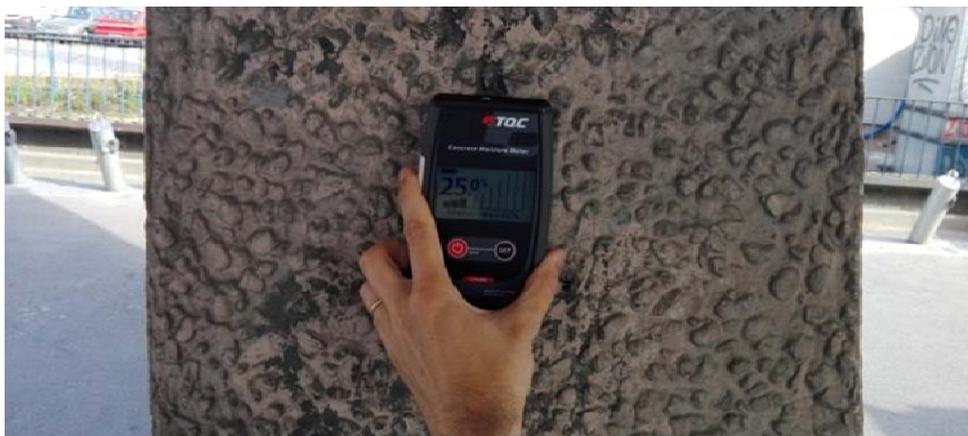
Figure 46: Moisture measurement from Srodmiescie WKD Station Pavilion column interior face. Source: INES Ingenieros 2018.

The thermographic analysis was completed with punctual moister measurements to confirm if those damaged areas actually had a higher moister percentage value than others and resulted to be true.

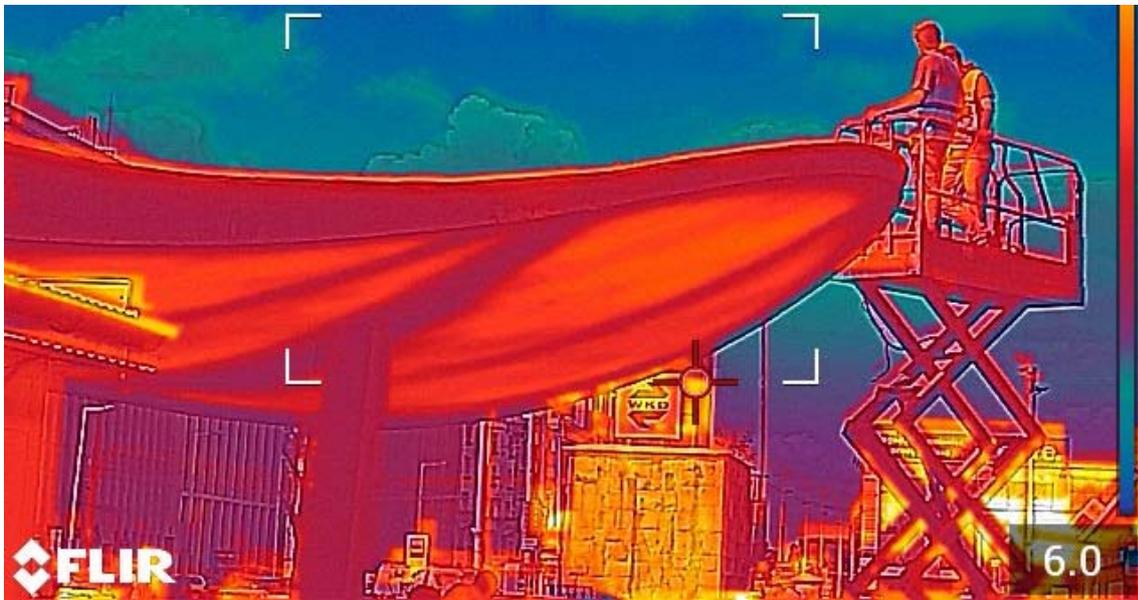
Figure 47: General thermographic measurement of Srodmiescie WKD Station Pavilion. Source: INES Ingenieros 2018.

During the survey, the team had the good chance of having sunny and rainy days, so thermographic images could be obtained from the complete structure. By overlaying the results from this thermographic results and the damage mapping, the team could reach conclusions that can explain the origin of many of the problems that appear in the structure. Thus, moister, calcareous crusts, delamination, spalling problems and the presence of vegetation can be in most of the cases explained due to the locations belonging to a moister concentration area.

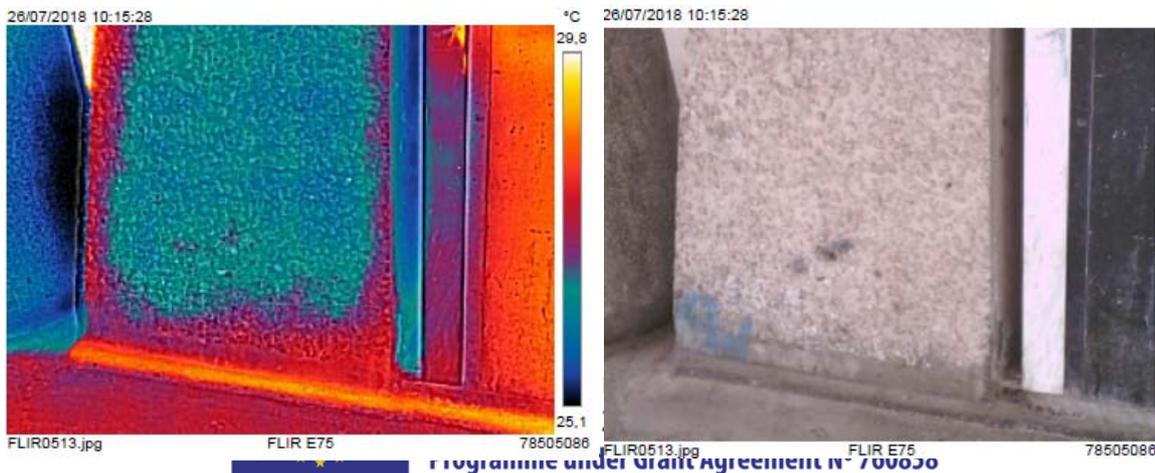
Figure 48: Thermographic measurement of Srodmiescie WKD Station Pavilion column bottom section showing moisture problems not at sight. Source: INES Ingenieros 2018.

Thus, it can be concluded that the most of the durable damages are due to the rainwater exposure together with the concrete carbonation and low concrete cover values.

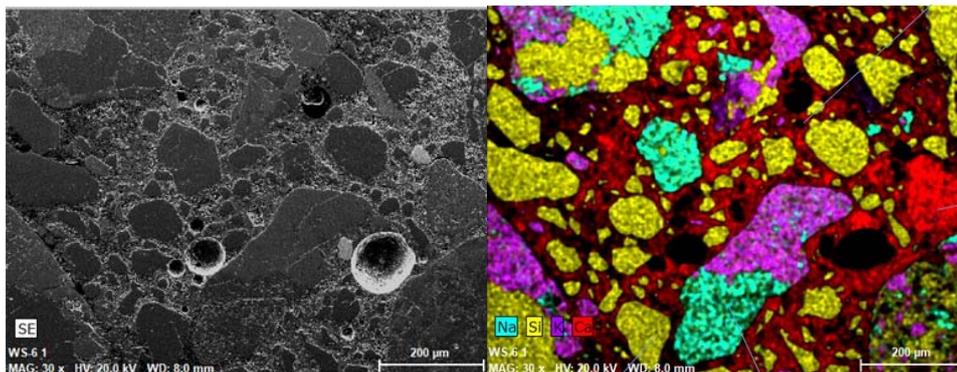
Figure 51: Left picture shows SEM image corresponding to WS6 sample and right image mapping showing the distribution of elements. Source: INES Ingenieros 2018.

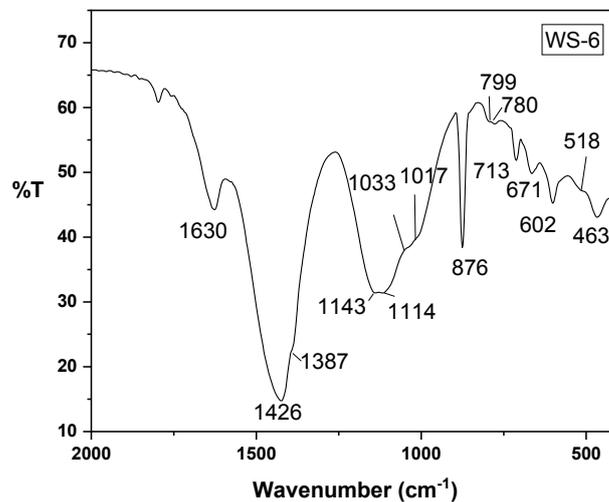
Finally, as an additional checking of the crystallization of the salts, these were analysed with Fourier Transform Infrared Spectroscopy, also known as FTIR Analysis or FTIR Spectroscopy. From this analysis, very similar results to what obtained by the saline extraction, showing again the high concentration of Ca and not providing any significant new data of interest.

Figure 53: WS6 Sample FTIR analysis. Source: INES Ingenieros 2018.
